# Rodding Out an N Tractor Radiator

By: Dave Smith

This radiator came on my 1941 9N when I bought it.

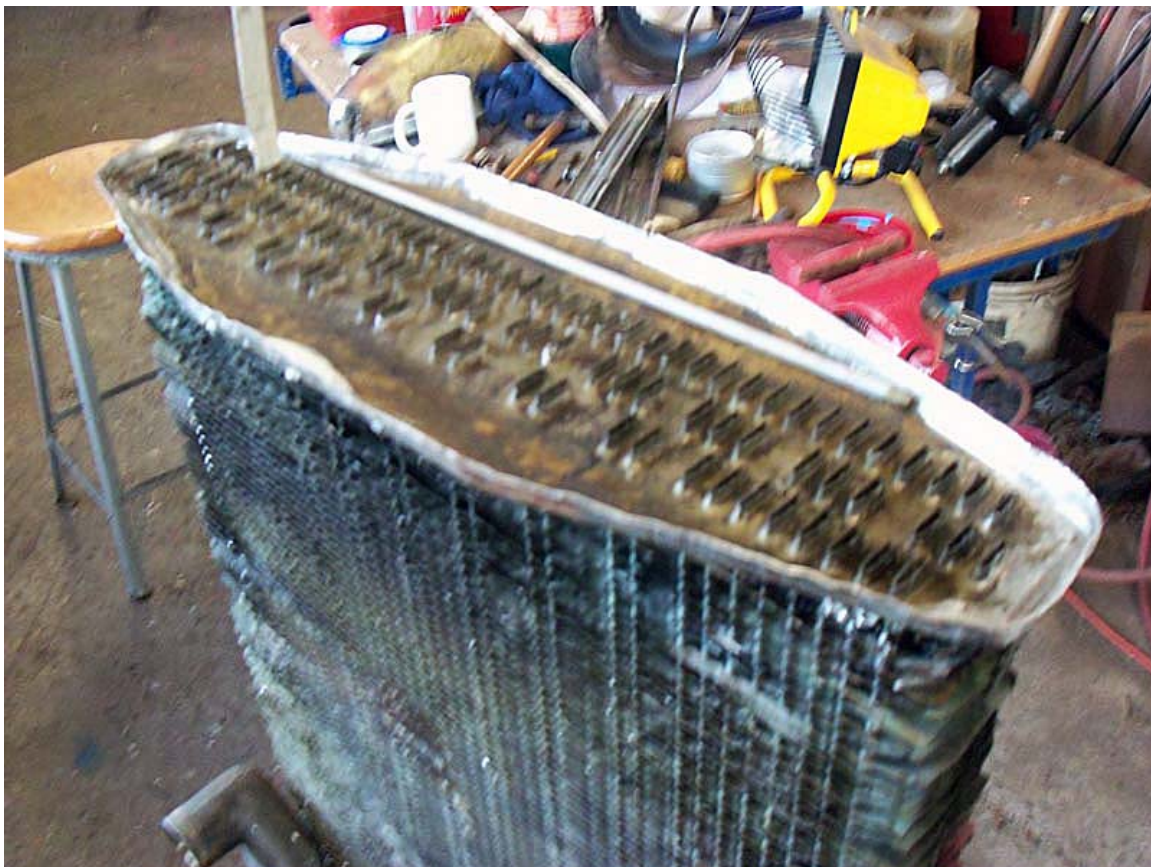
First I unsoldered the top tank using a propane torch and air. When doing this be sure to wear protective clothing and face shield and be aware of where you are blowing the molten solder to.

There are exactly 100 tubes in this radiator. Also notice that there are more tubes in the front of the radiator than in the center or rear. Also the rear has more tubes on the right than on the left.

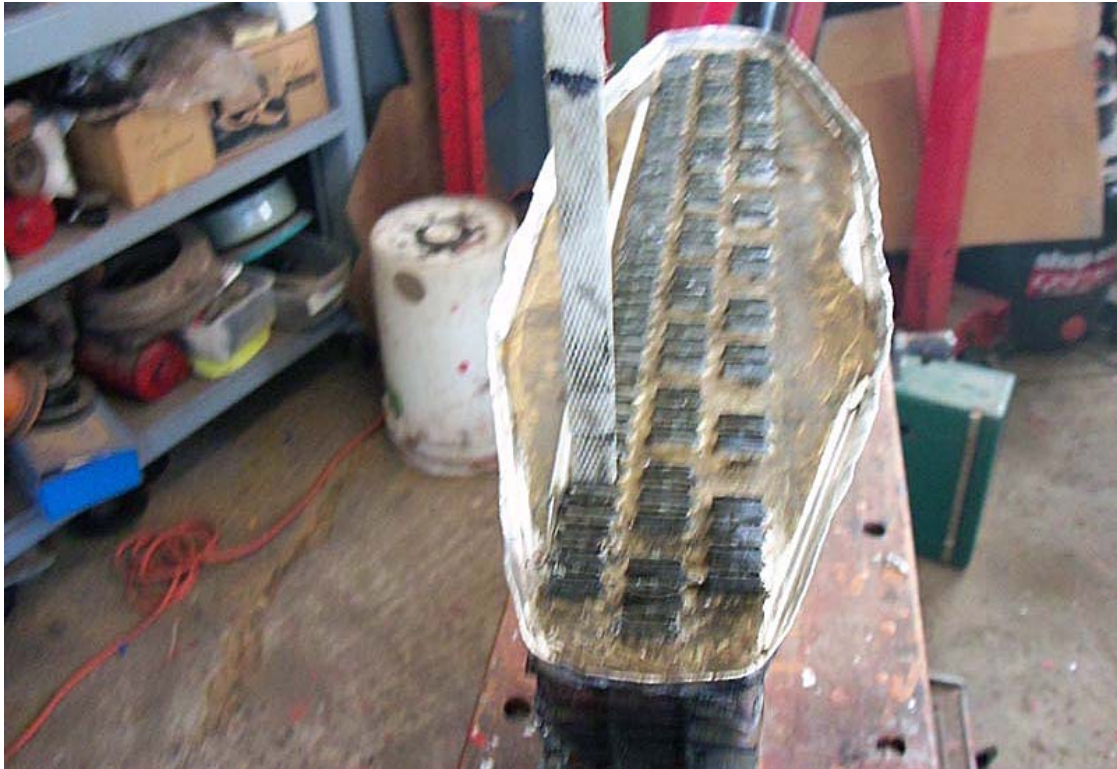
I used a piece of plastic banding to shove through the tubes. One tube had been damaged in the past and had been soldered off. All the rest I had no problem getting the band through. The plastic band fit the tubes very nicely.

Then I took the radiator to the laundry tub and scrubbed it and ran hot water with detergent (Purple Power) through the tubes. After a good cleaning, I soldered the top tank back on and soldered on a filler neck.

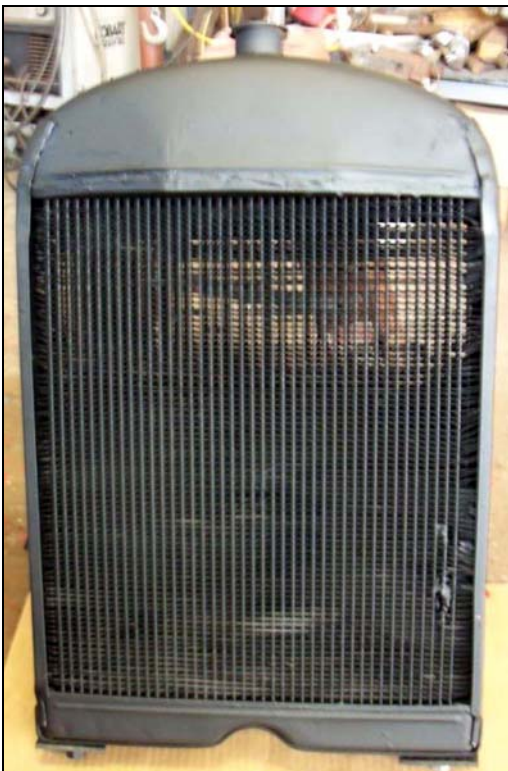
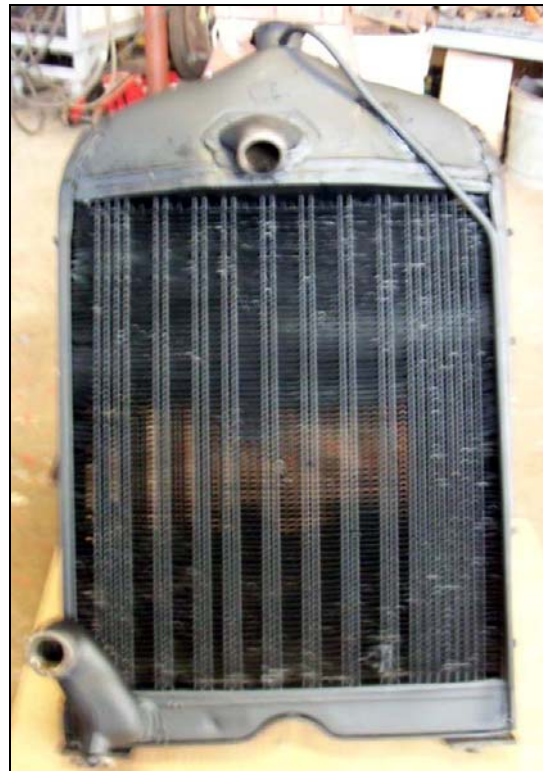
After washing again with hot water and detergent I painted it flat black.

Now to pressure test it. I do not have a pressure regulator that I can set low enough to use here. So I plugged the inlet and outlet openings. While I blew compressed air into the filler neck, I had a helper spray soapy water all over the radiator to detect bubbles or leaks.
