Power Steering Upper Shaft Seal Replacement

This is the procedure for replacing the seal who's symptoms when failing is power steering fluid leaking from under the steering wheel. This seal replacement was performed on a 3 cylinder model 2600. Your model may be different but the same principals probably apply. For detailed instructions, follow along with the appropriate I&T shop manual.

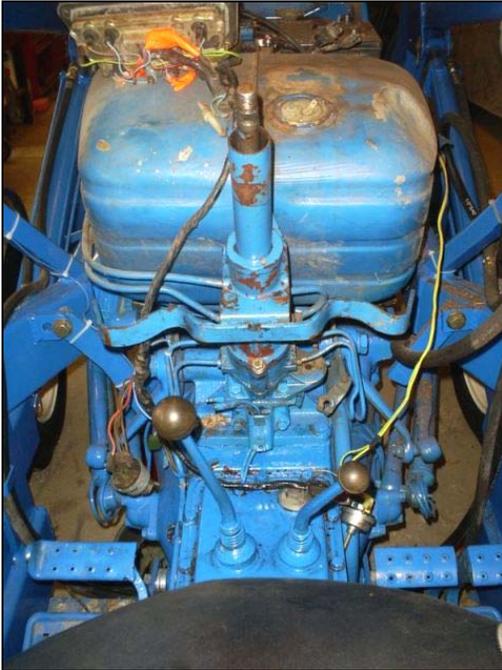
Remove the dash support and finally the 3 bolts holding the steering column upper casting on exposing the lower steering assy.

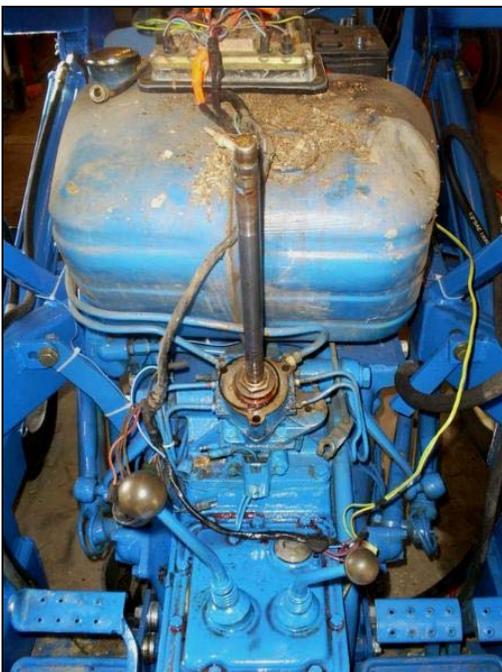
Once the upper casting is removed the lower steering assembly is visible along with the steering shaft that the seal runs against.

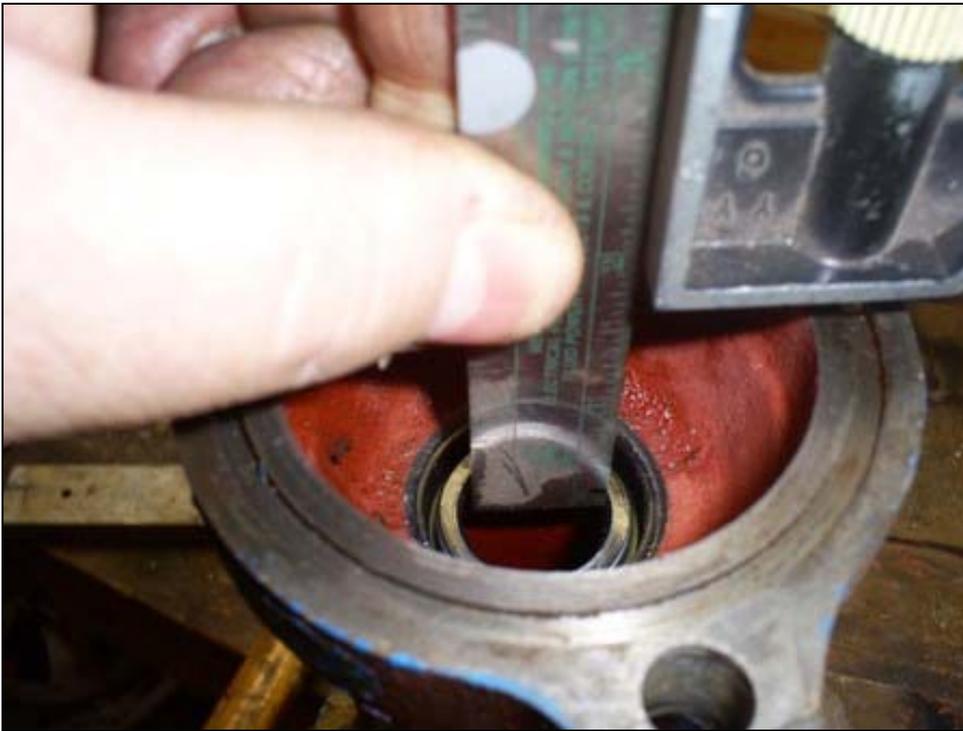
By measuring the depth of the seal in the casting, you can determine where the seal runs against the shaft. With the old seal removed you can also measure the casting and subtract for the area in the seal. In my case the lip of the seal is located $1 \frac{9}{16}$ from the base of the casting. We will use this dimension for locating the Speedi-Sleeve later.

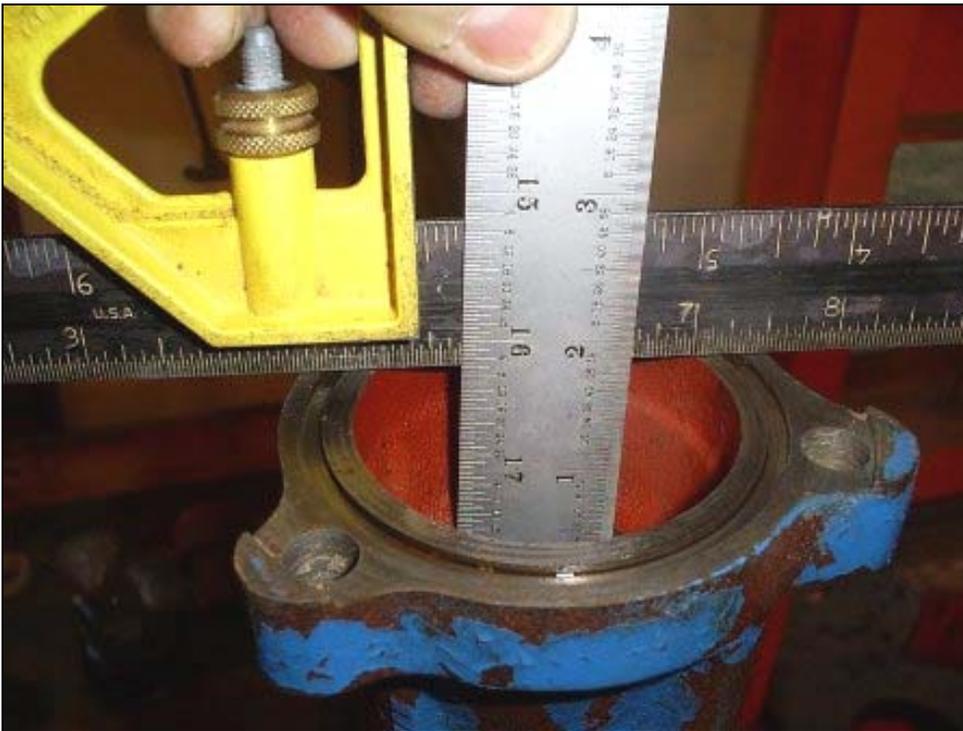
This is a measurement of the casting with the old seal removed. We need to subtract the distance from the surface of the seal to the lip.

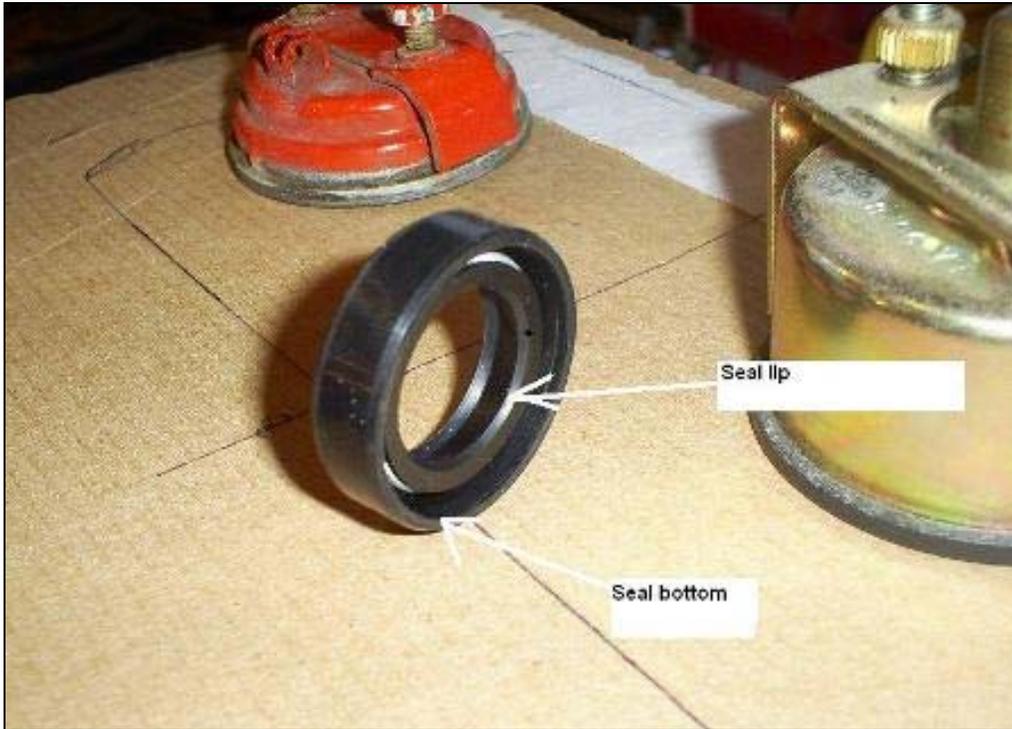
Here's a picture of the new seal. Note the bottom of the seal goes towards the lower steering assy.

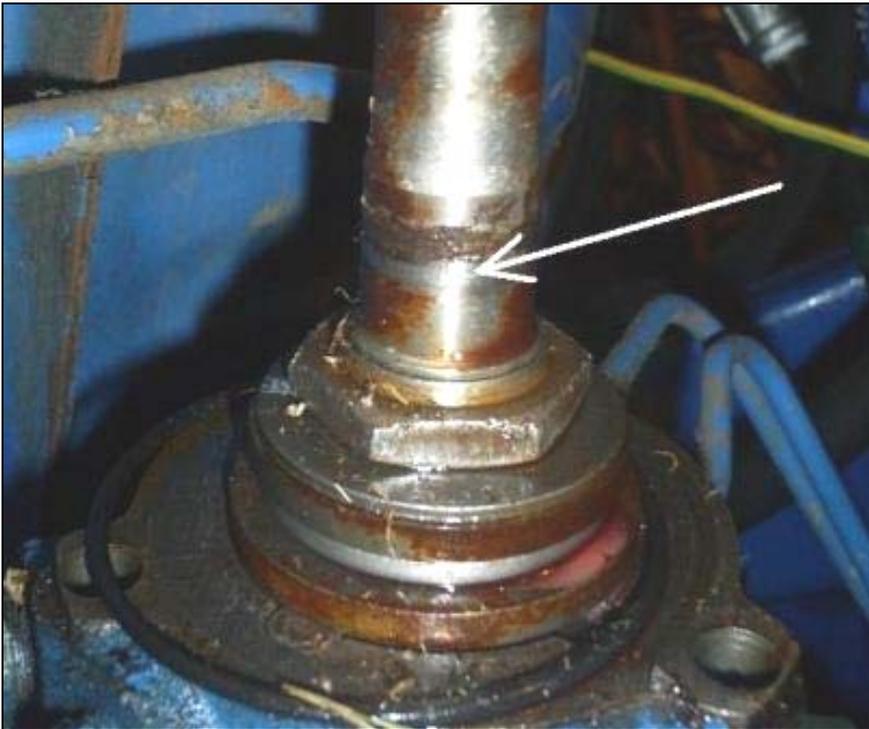
In this picture, the area where the seal mates to the shaft is indicated with a white arrow. It's easy to see the pitting and rust just above the seal area. It's important to note that the steering shaft moves up and down approx 1/8" from center during normal operation. It's likely that in this case when the shaft drops the seal lip is on the pitted area which is responsible for premature seal failure.

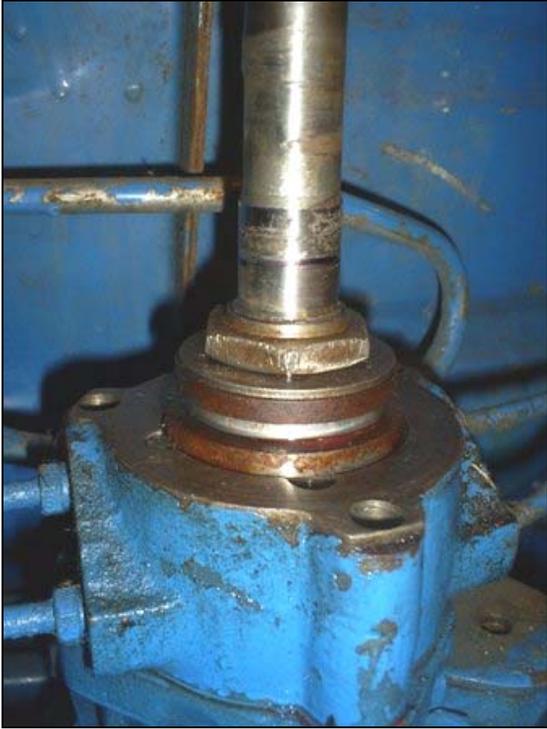
At this point polish the mating surface with 400 grit emery cloth. This is the result of cleaning mine. Notice there is pitting remaining, this is not a good sealing surface. I have also measured the distance to the lip seal area and marked with a pen. The replacement seal kit I ordered came with a Speedi Sleeve which we will use. The pitting is from water entering the top of the steering column and lying on top of the seal area promoting rust and corrosion.

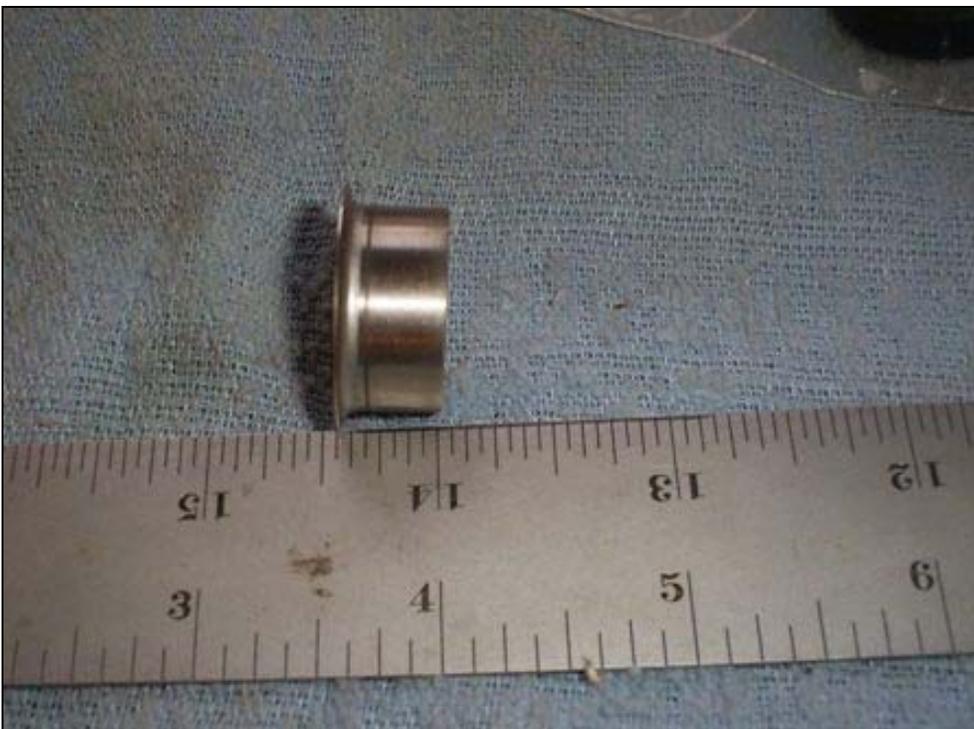
This is a picture of the Speedi Sleeve that came with the kit. It's a very thin machined piece of Stainless steel that provides a new sealing surface without having to re-machine the shaft. It has a flared collar to aid installation that will be removed when completed. The kit comes with a bigger sleeve that fits over this one that you drive against to move the Speedi-Sleeve into position. Notice the groove on the left side near the flair; this is where the flair breaks away when installed.

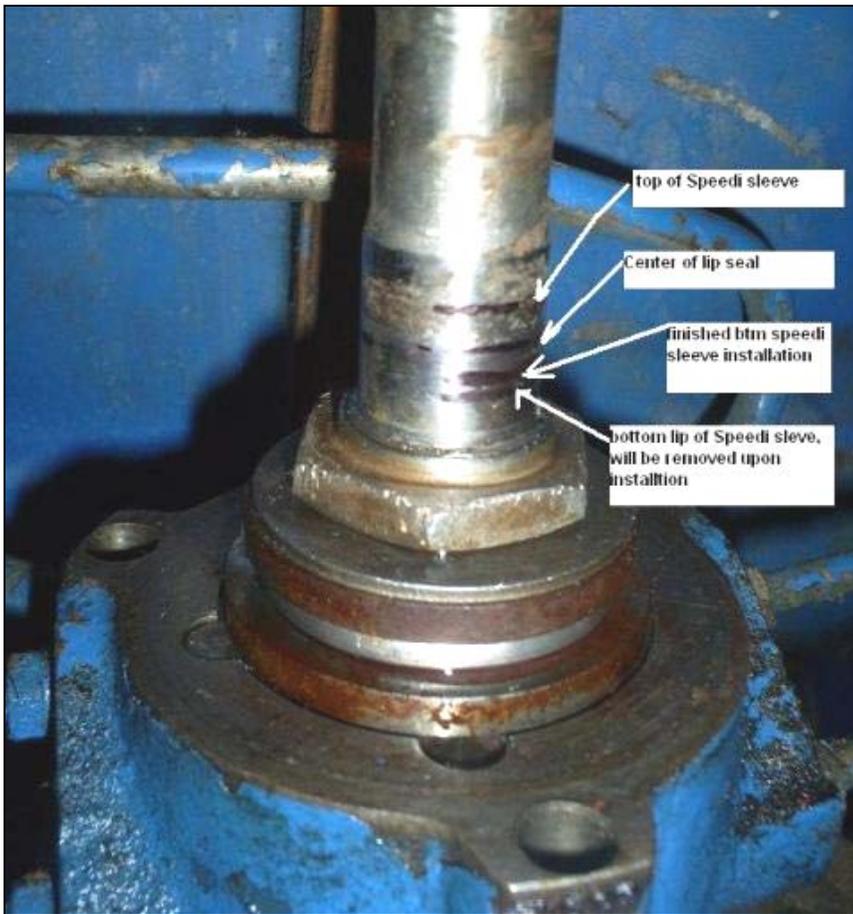
After doing some math I determine where the Speedi Sleeve needs to be installed. The photo shows the marks for the installed top of the sleeve, center of the lip seal, the bottom of the usable Speedi Sleeve and the bottom of the Speedi-Sleeve prior to removing the lip.

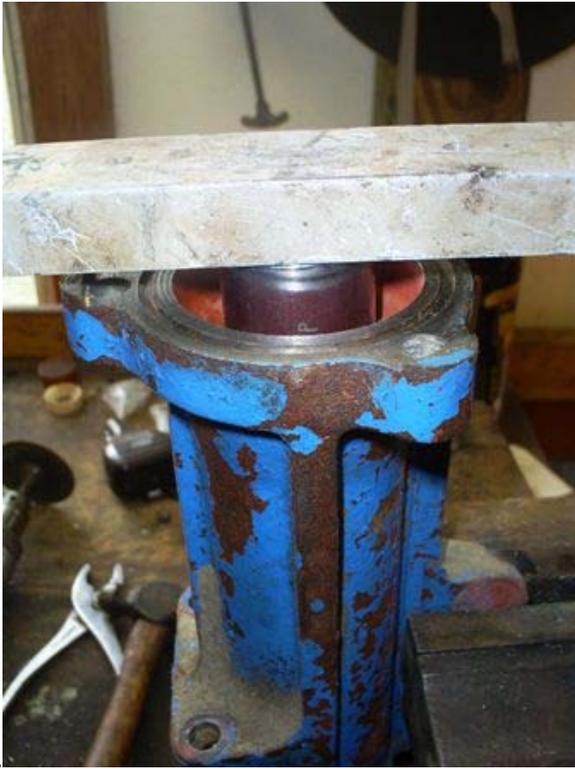
Install the new seal into the upper casting. I used a socket of the same O.D, a short piece of heavy bar stock, and a hammer. Drive carefully and its ok to lube the seal to aid installation. Make sure the seal is completely bottomed out in the casting.

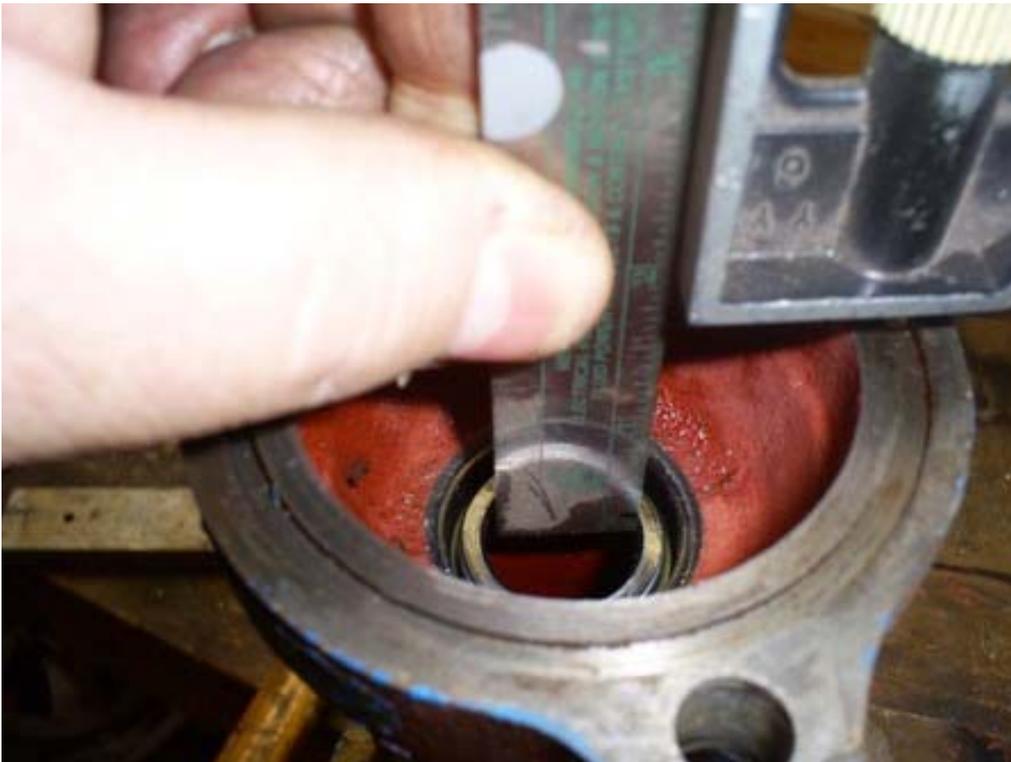
At this point I measured the actual lip of the new seal to verify the math was right. Apparently I did ok as it matched what I expected.

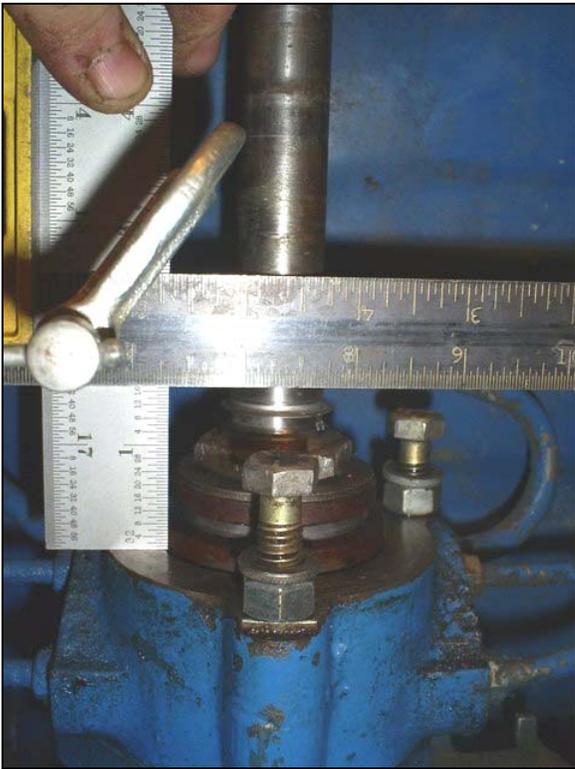
In the following picture, I have driven the new Speedi Sleeve down to just above my marks. From this point on I use a square and a machinist ruler to locate the sleeve. I have also installed the 3 bolts temporarily to hold the bottom block down tight. The photo shows me checking to see if the lip of the new seal lands in the middle of the Speedi-Sleeve.

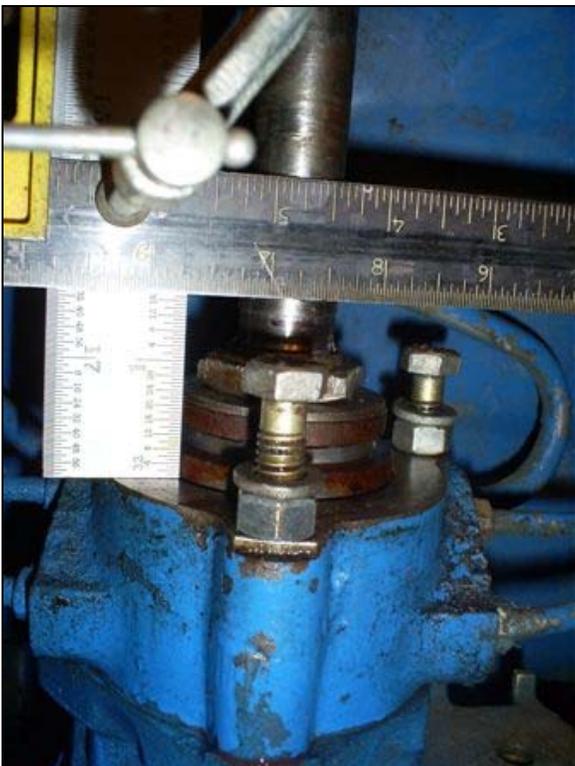
After driving the Speedi Sleeve to the proper location, I removed the flared lip and did a final check, if I've done the math right, the lip on the new seal will land exactly in the middle of the new Speedi Sleeve. Instructions for installing the Speedi-Sleeve were in the seal kit I purchased through YT.

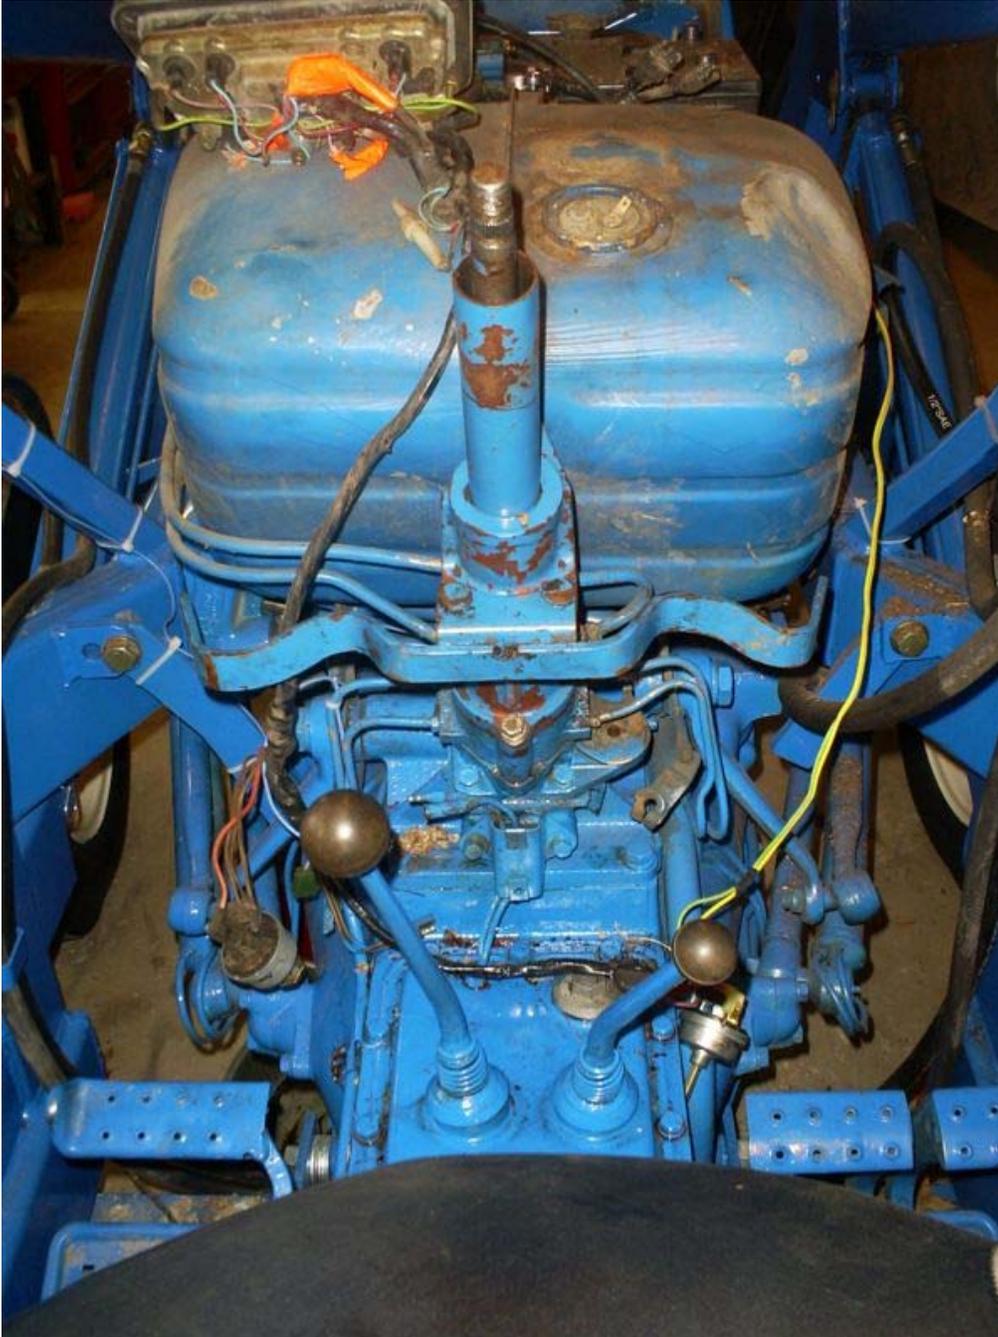
From here I lightly lubricated the new seal and reinstalled the upper casting with the new seal. It dropped onto the shaft and stopped at what I believe is the Speedi-Sleeve where it required just a little force to go on down.
