Rebuilding a Sherman Combination Transmission by John Smith (<http://www.oldfordtractors.com/screbuild.htm>)

SHERMAN STEP-UP AND STEP-DOWN COMBINATION TRANSMISSION

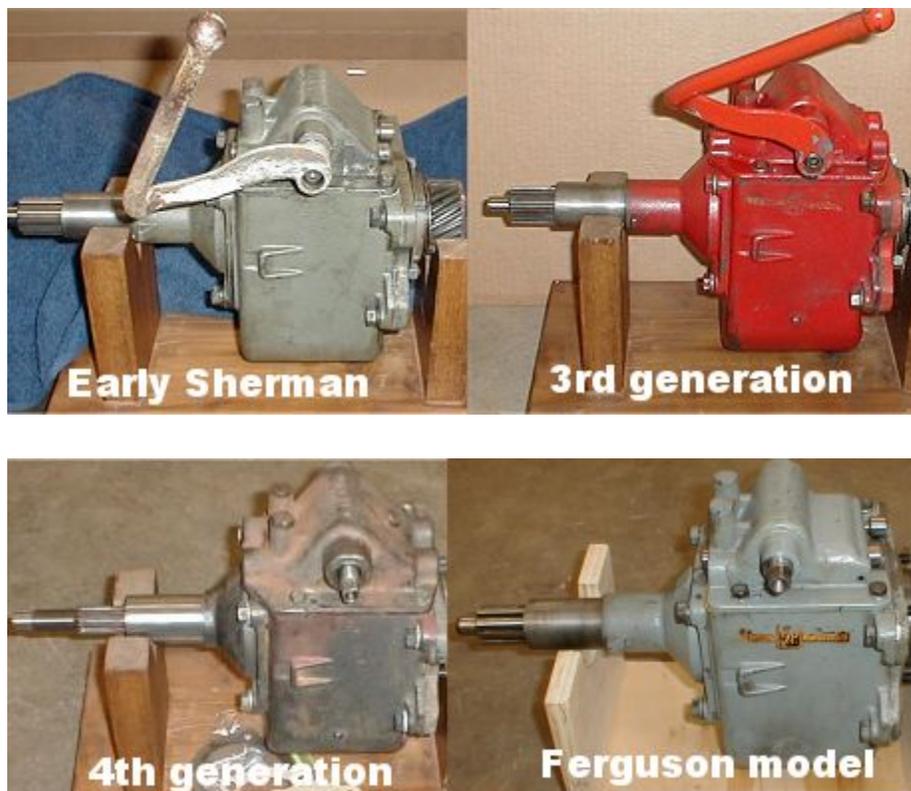
Before disassembly a quick look at the outside reveals major problems with the output shaft.

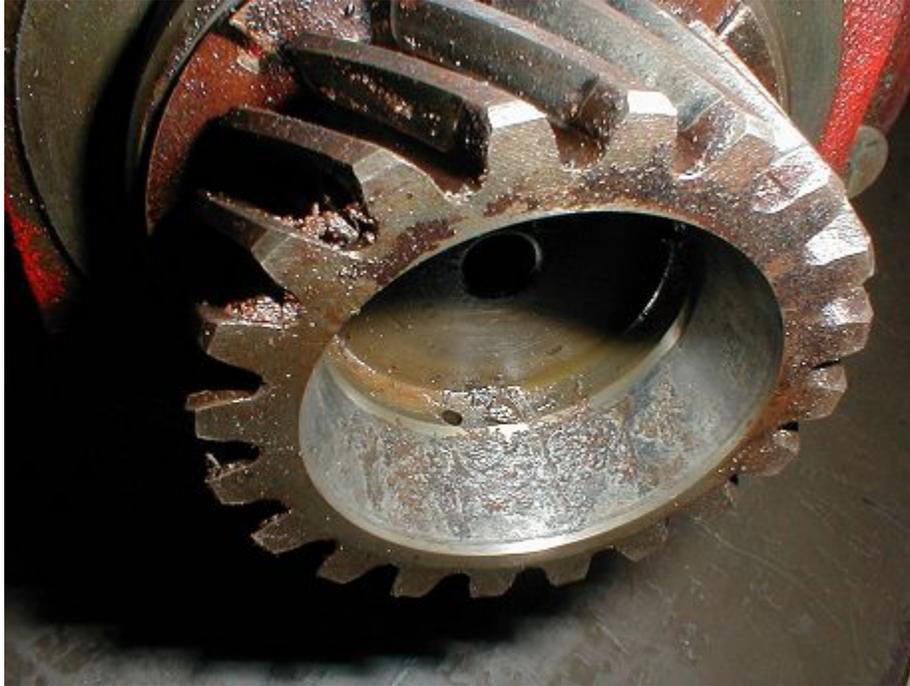
There is serious rust pitting in the back of the output gear. This area is actually the bearing cup or "race" for the front Timken bearing on the tractor's mainshaft. The bearing race surface must be smooth. Installing it like this will mean a growling noise and vibration that will soon destroy the bearing on the tractor's mainshaft. This pitted output shaft is junk and this has quickly become an expensive Sherman rebuild.

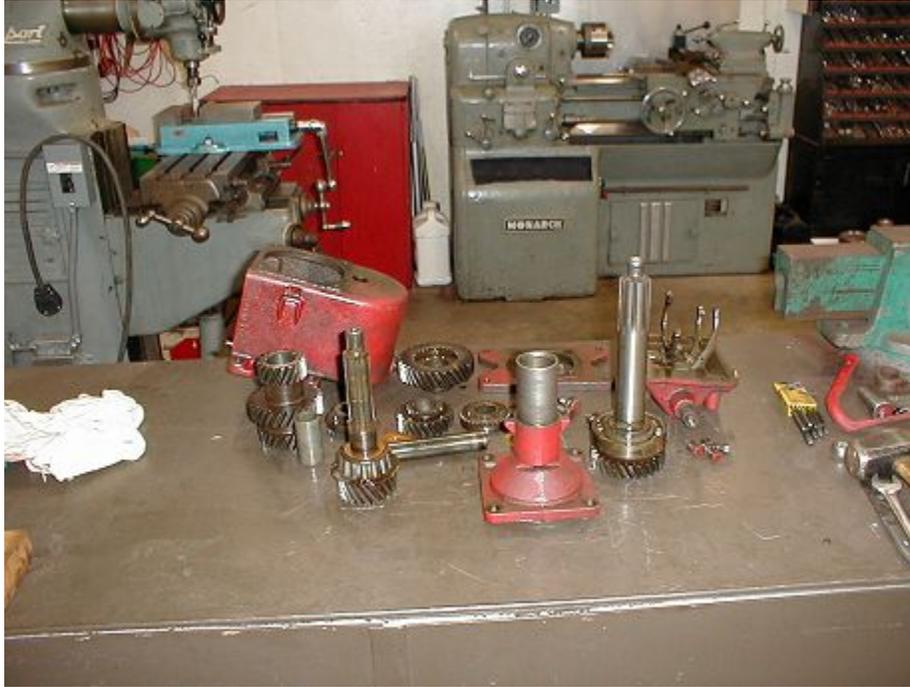
It takes only a few minutes to have the Sherman all apart. Here it's disassembled and ready for a solvent bath.

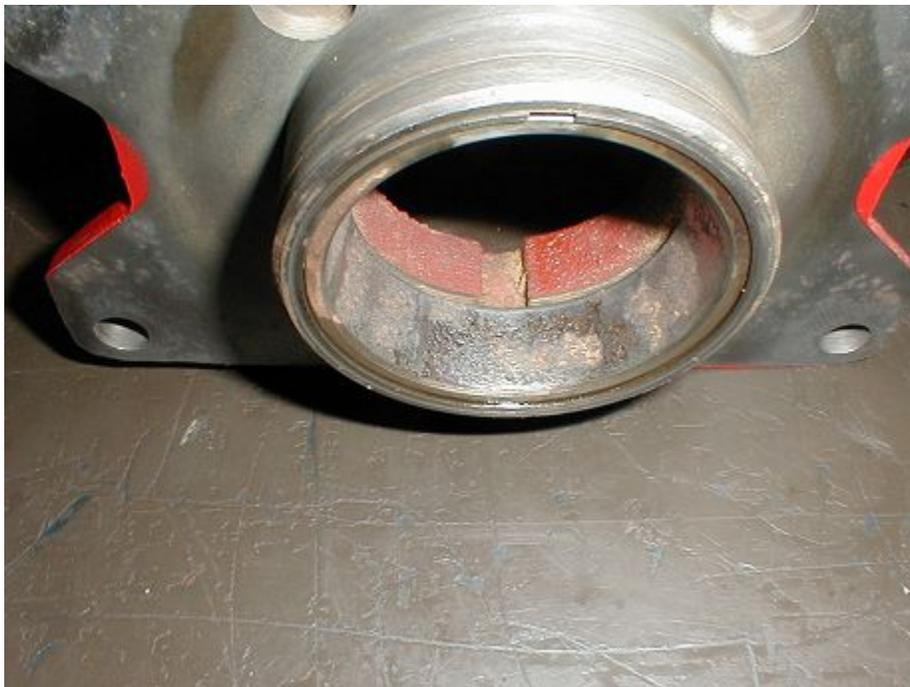
Starting with the main case we find the output shaft bearing race (cup) is badly rusted and needs replaced.

The 2 notches on the inside of the case will let you use a punch to knock the old bearing race out.

The case has been cleaned, inspected, and a new bearing race installed.

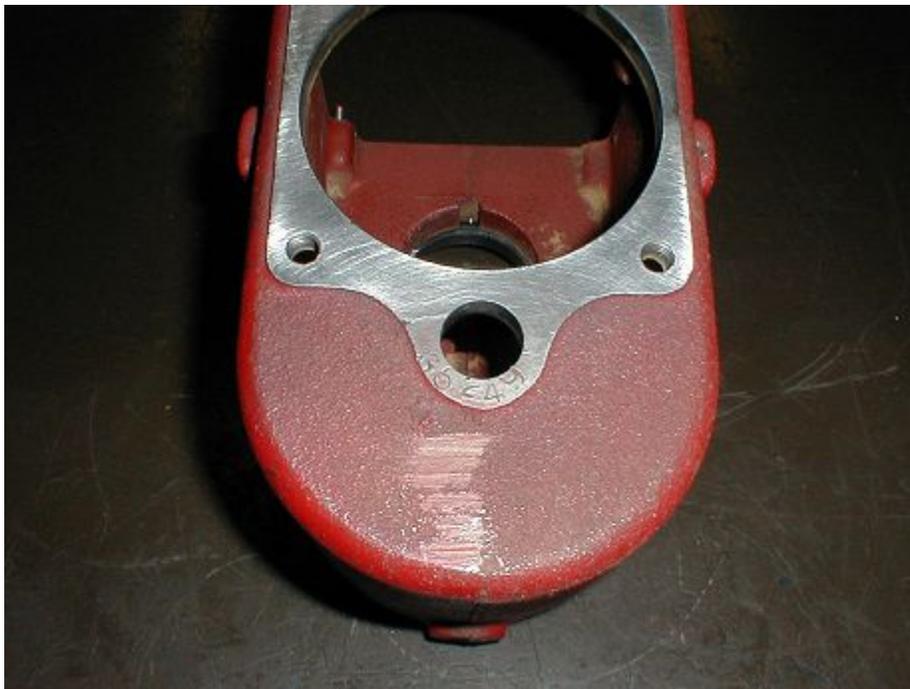
Clean and inspect the case for any cracks or other flaws. All the Sherman combinations have their serial numbers on the front of the case below the countershaft bore. The earliest number we've seen was in the 3000 range and the latest on a Ford case was in the 75000 range. This one is serial number 36249.

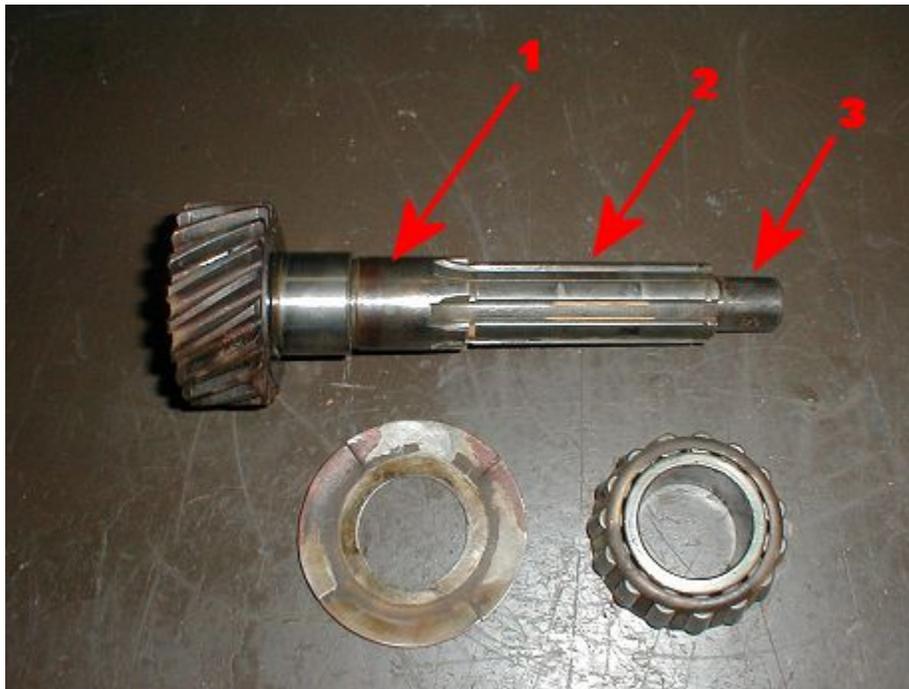
If the rear bearing cup on the output shaft was ok we'd need to check out the rest of the shaft. Diameter #1 is where the step-down gear rides on the shaft. There should be no wear or scoring on this surface. If there is a problem here there will also be a problem in the bore on the step-down gear. Diameter #2 on the splines is where the step-up gear rides on the shaft. Wear here is fairly common and it's not good. A couple of thousandths wear is ok but any more requires a new shaft. Wear here also indicates there is likely a problem in the bore of the step-up gear. The step-up gear can become rippled inside and will also need to be replaced. Diameter #3 is the inside shaft for the needle bearing on the main shaft. It should have no wear or pitting. If it does, the needle bearing won't last long.

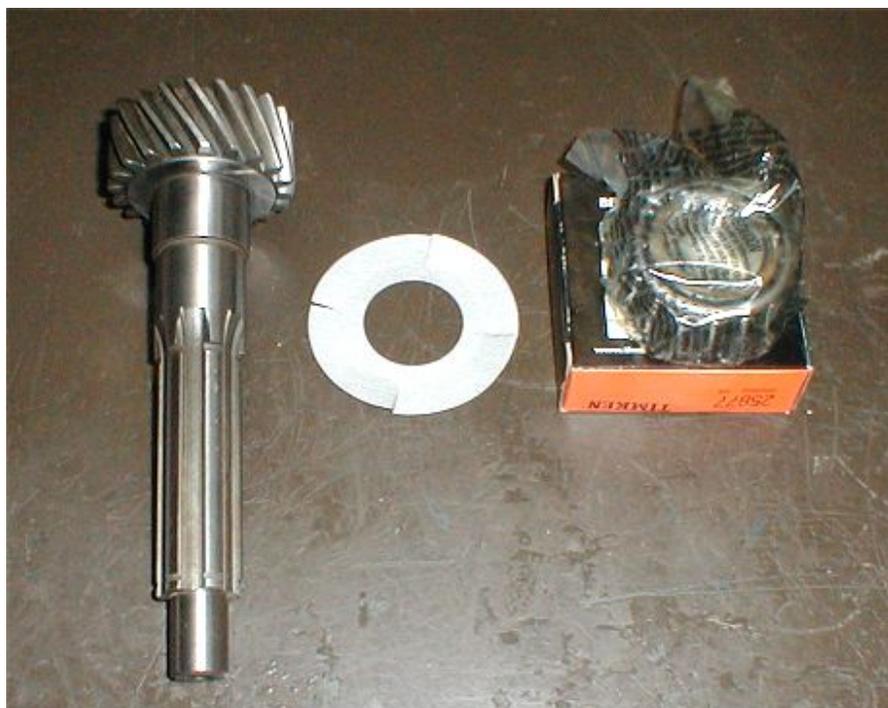
The new output shaft, slinger and bearing ready to assemble.

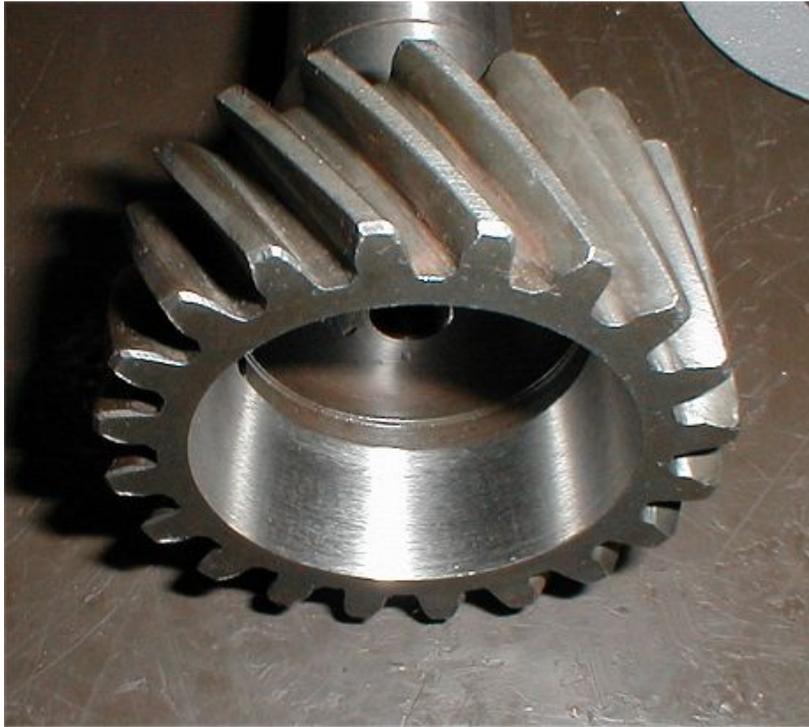
The bearing cup end of the output shaft should look like this or close to it. Very minor pitting can be acceptable if the pits are small enough that none of them span the length of a roller on the bearing. If there is any pit or flaw big enough that a roller can be affected by it, the bearing will be noisy and will soon fail. That could mean big trouble.

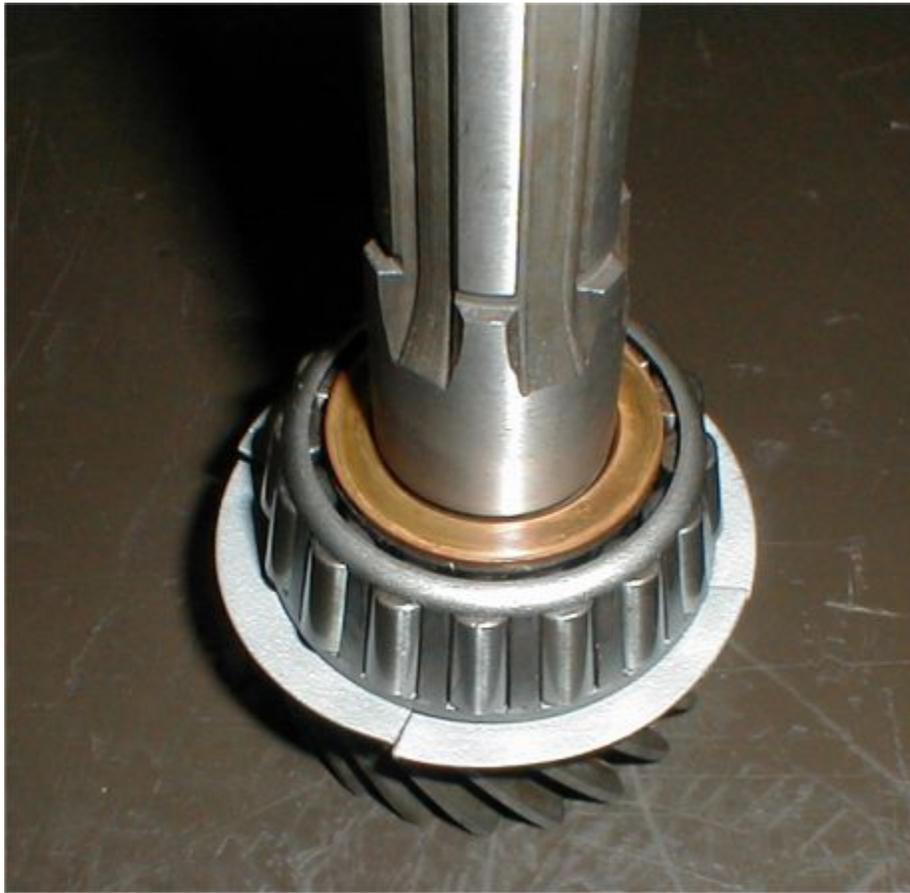
Drop on the rear thrust washer and the output shaft is ready to install. This washer should be .062-.065" thick.

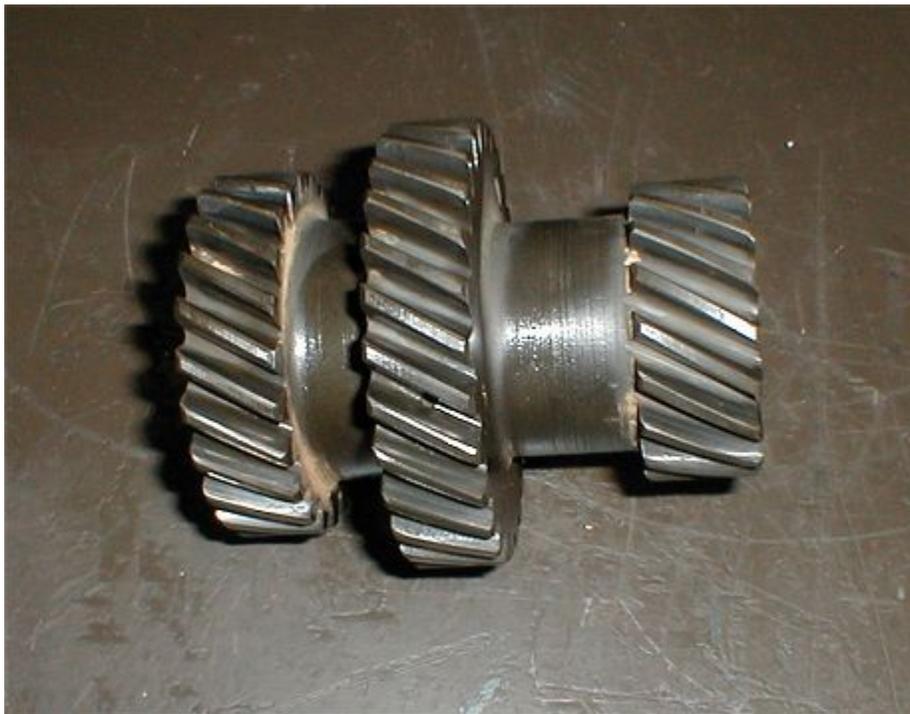
Next, closely inspect the lower cluster gear. All the gear teeth should be in good shape with no abnormal wear. Fortunately, the cluster gear in this transmission is a good one.

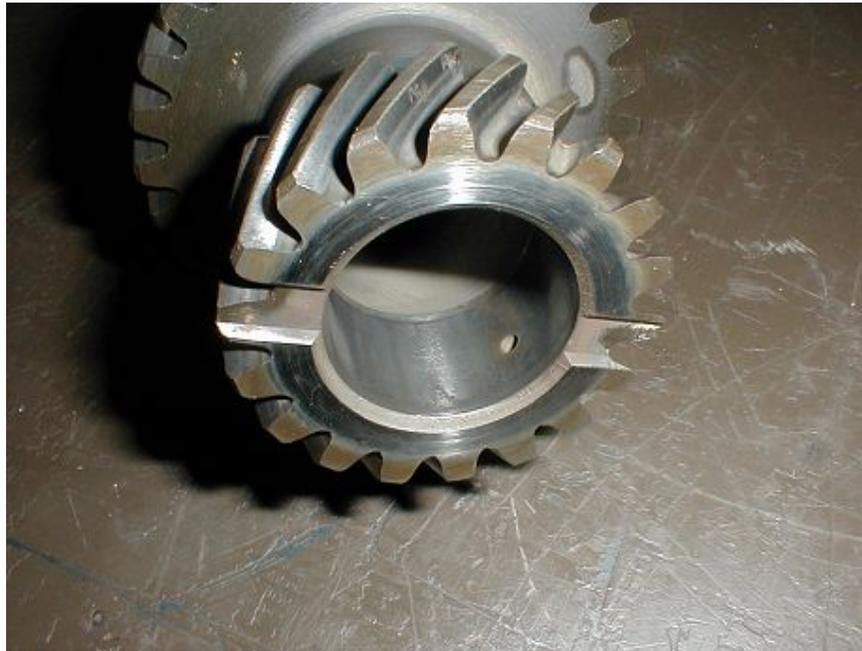
The needle bearings for the countershaft run directly against the inside bores of the cluster. Inspect the bore on each end for any pitting or damage to the bearing surface. It should be smooth and free of pitting or any other flaws, just like this one. A rough surface here will cause growling noises and will soon destroy the lower bearings.

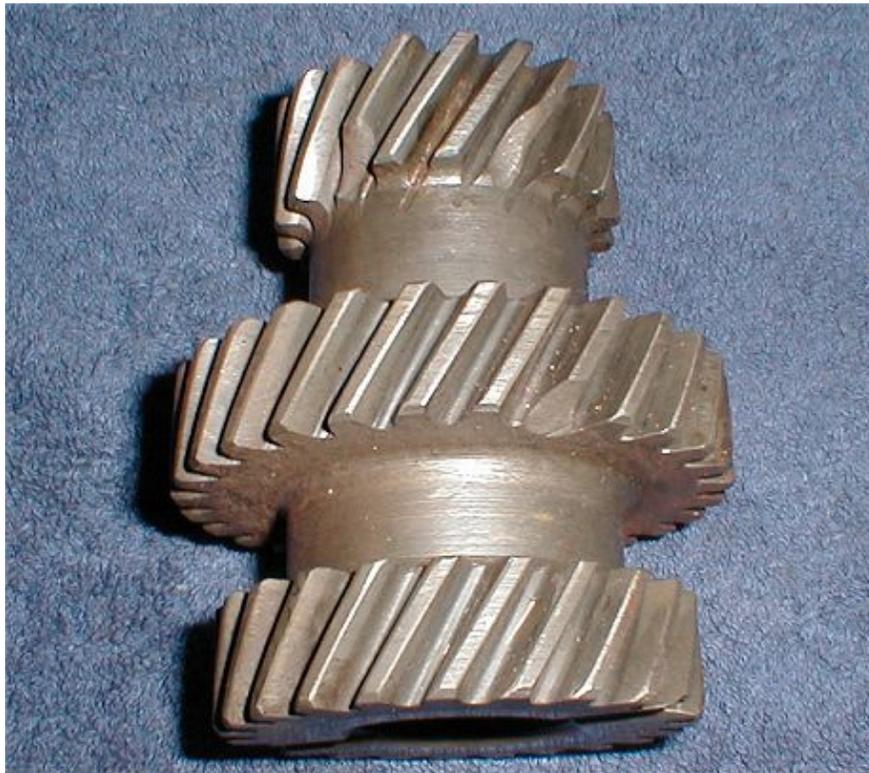
This is an example of a cluster gear that has 3 chipped teeth. It's junk. Chipped teeth on the cluster gear cannot normally be seen just by removing the top cover on the transmission. This is the type of hidden damage you do not want to find when you disassemble your Sherman.

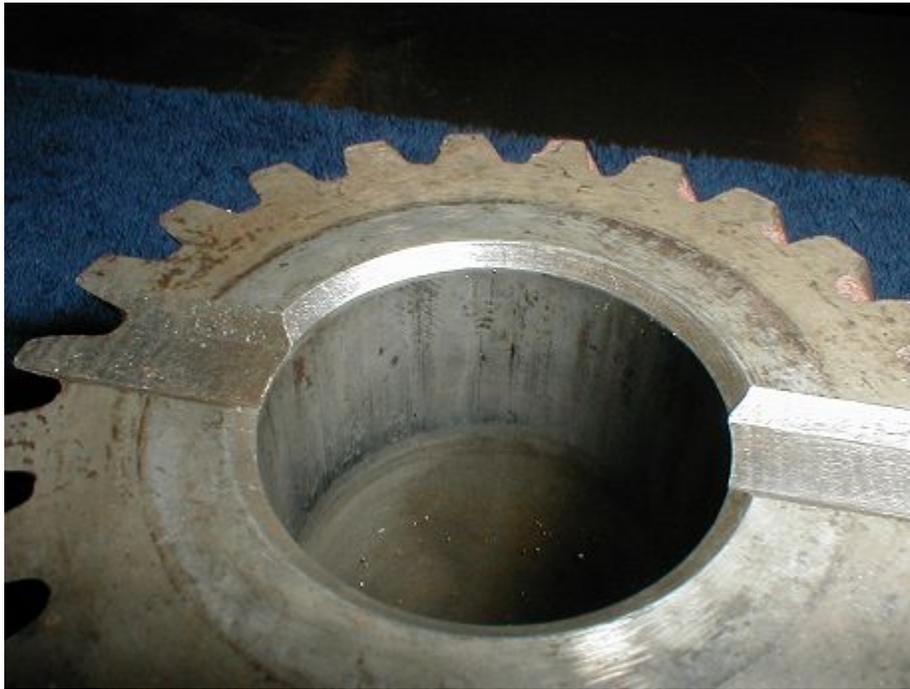
The bearing bores in this example cluster gear show some pitting along the length of the needle bearing area and some galling near the inside end. This is not good.

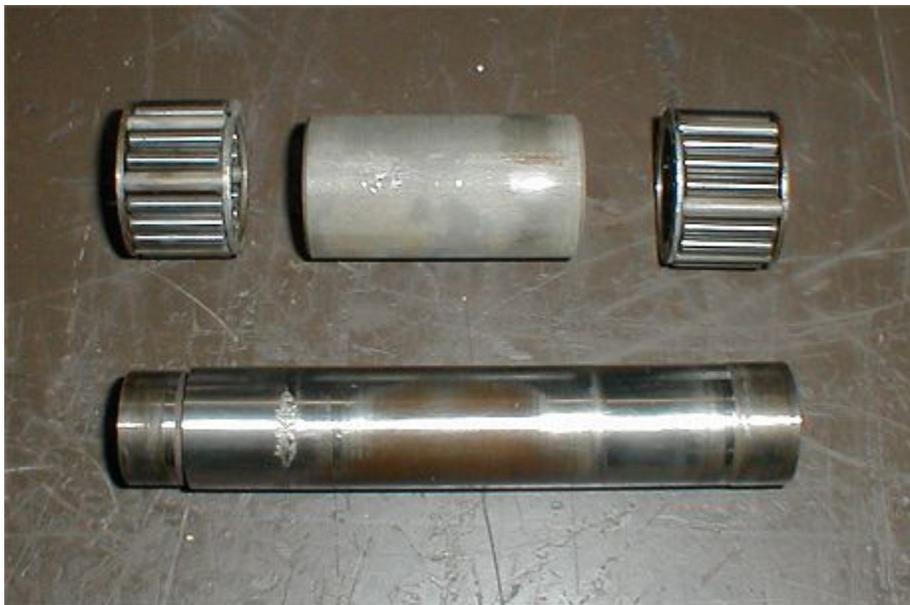
Many times when there is wear on the countershaft and/or cluster gear bearing diameters the bearings will come out in pieces. Note the galling on this countershaft front bearing diameter. This shaft is junk.

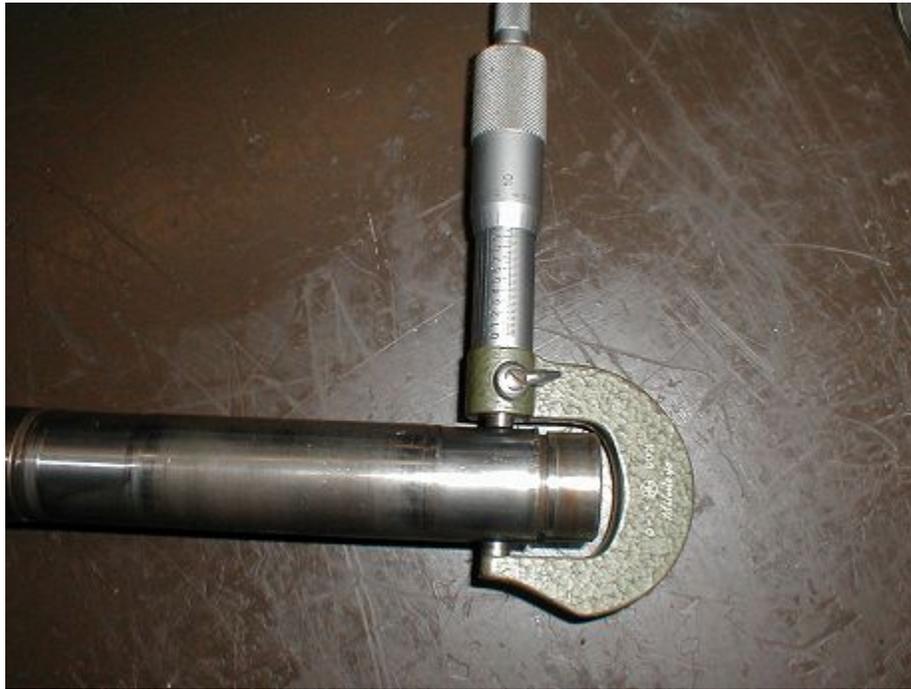
Measure the countershaft at the bearing diameters. It should be smooth and round and should be 1.000" in diameter. If the shaft is otherwise in good shape I will accept a size of .997" but no more than that. If it's worn too much the transmission will be noisy and the bearings will fail. This one is badly worn and measures .984". It's junk.

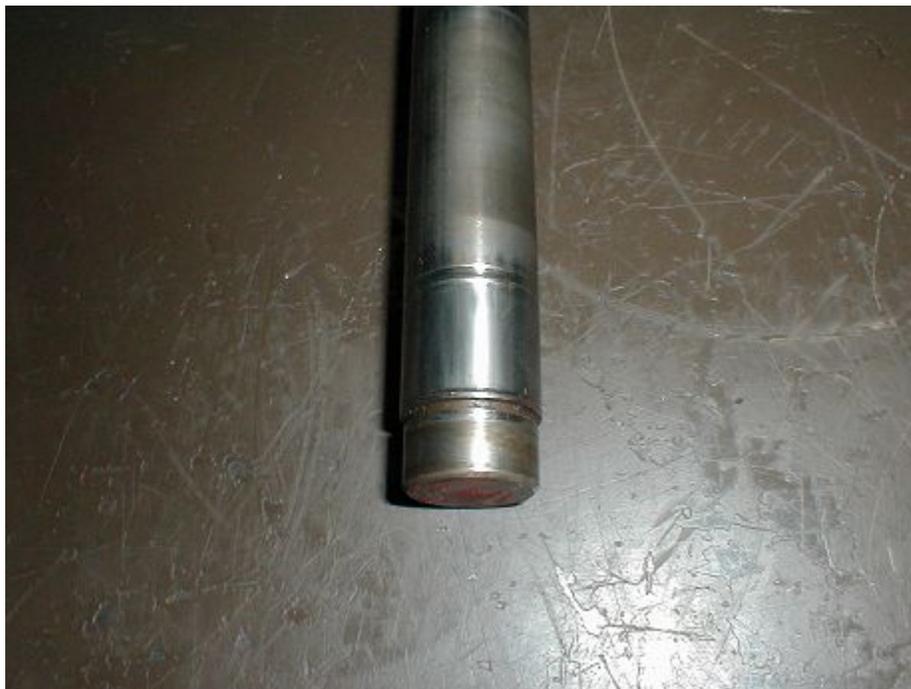
An example of a badly worn countershaft bearing diameter.

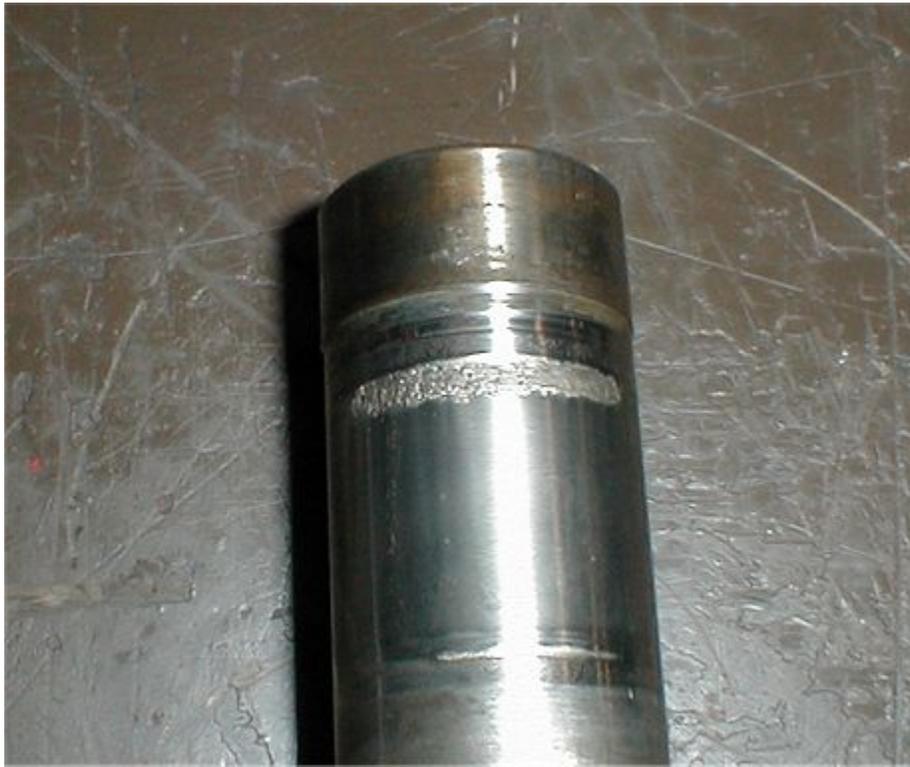
An example of galling on the rear end of a countershaft bearing diameter. More junk.

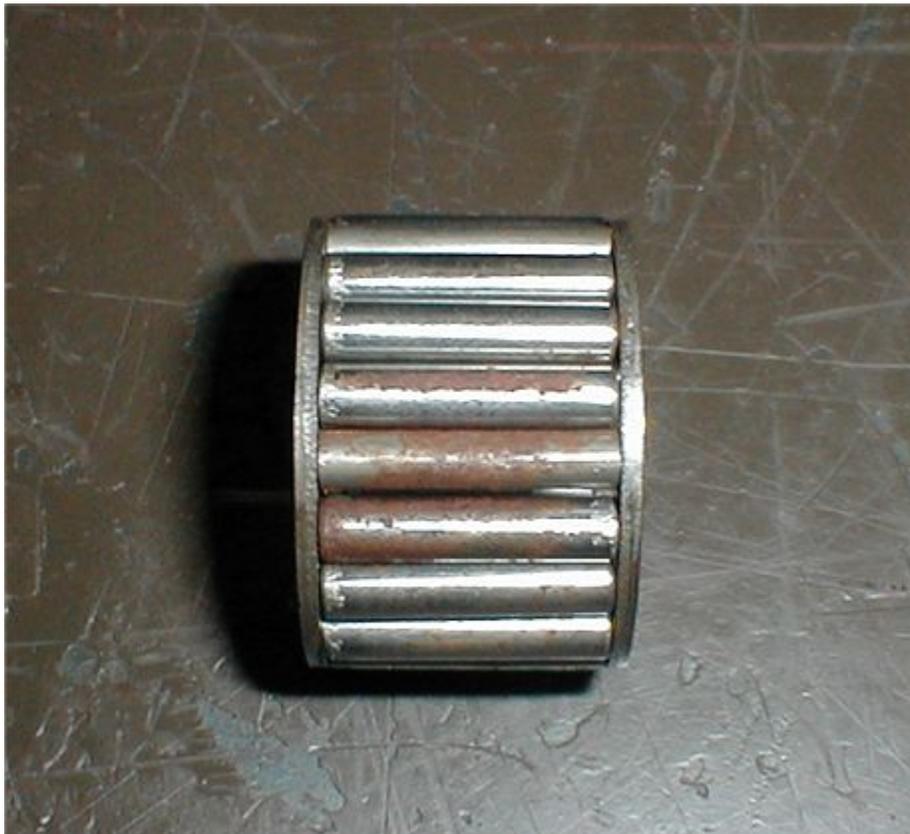
This needle bearing has rust and pitting on the rollers. The rollers are also starting to crumble on the left end. It's very rare to find any of these that are good enough to use over again. Replace 'em.

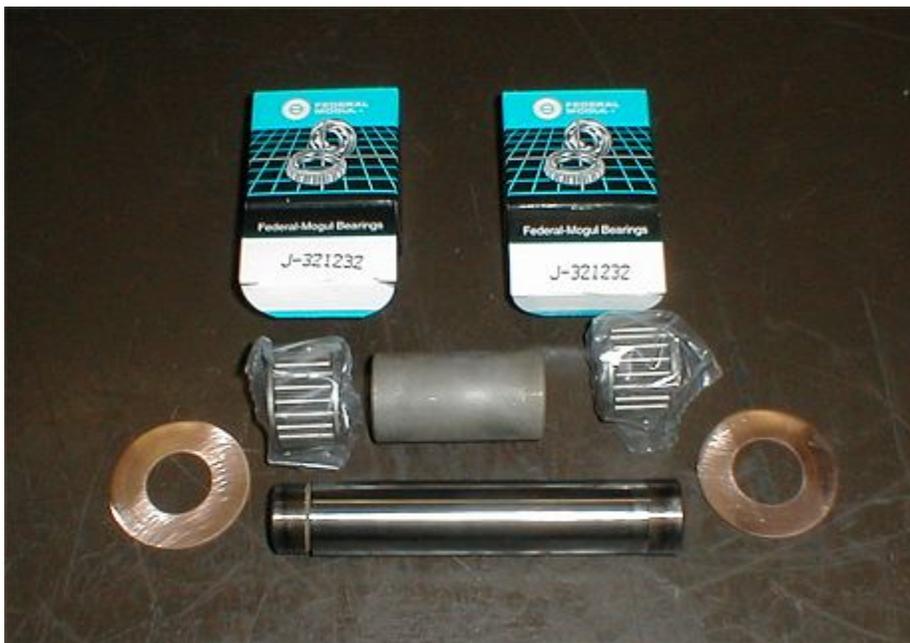
The countershaft with bearings and thrust washers ready to install.

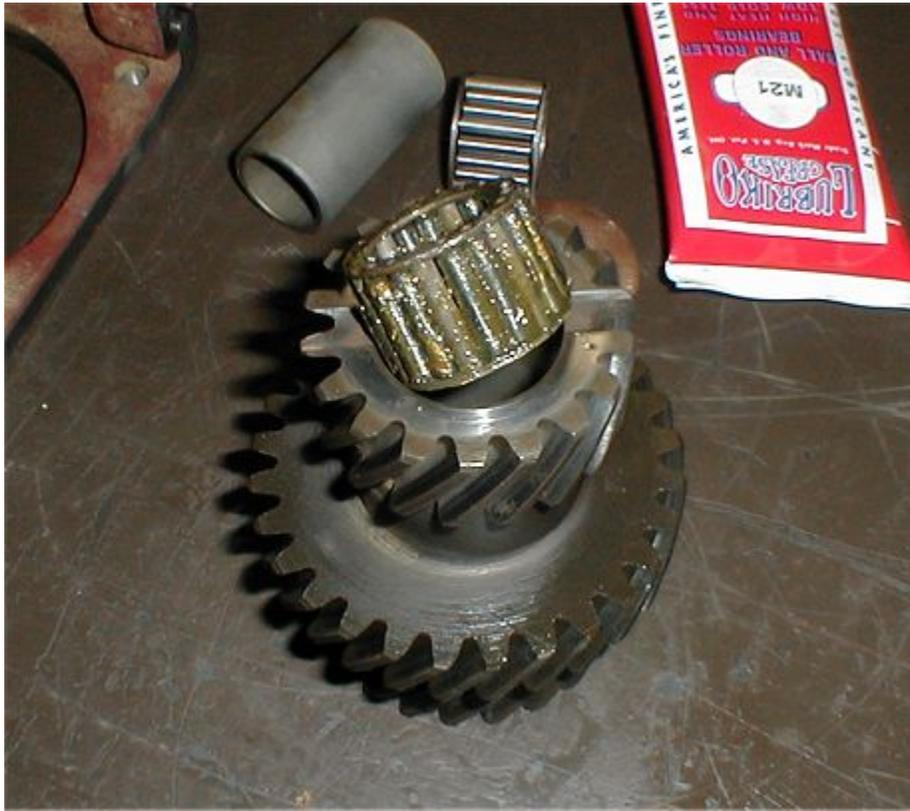
Install the 2 bearings and the center spacer into the cluster gear. Apply a good coating of assembly grease to all parts when installing.

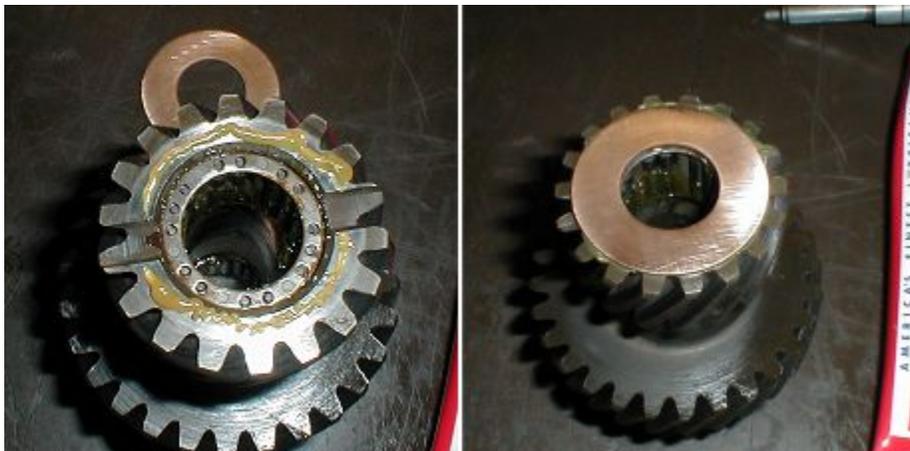
"Gluing" the thrust washers to the cluster gear with assembly grease will keep the bearings inside in place while you put the cluster assembly into the case. The small gear goes toward the rear of the case. Note - the front and rear end thrust washers are different. The one with the smaller hole goes on the front end.

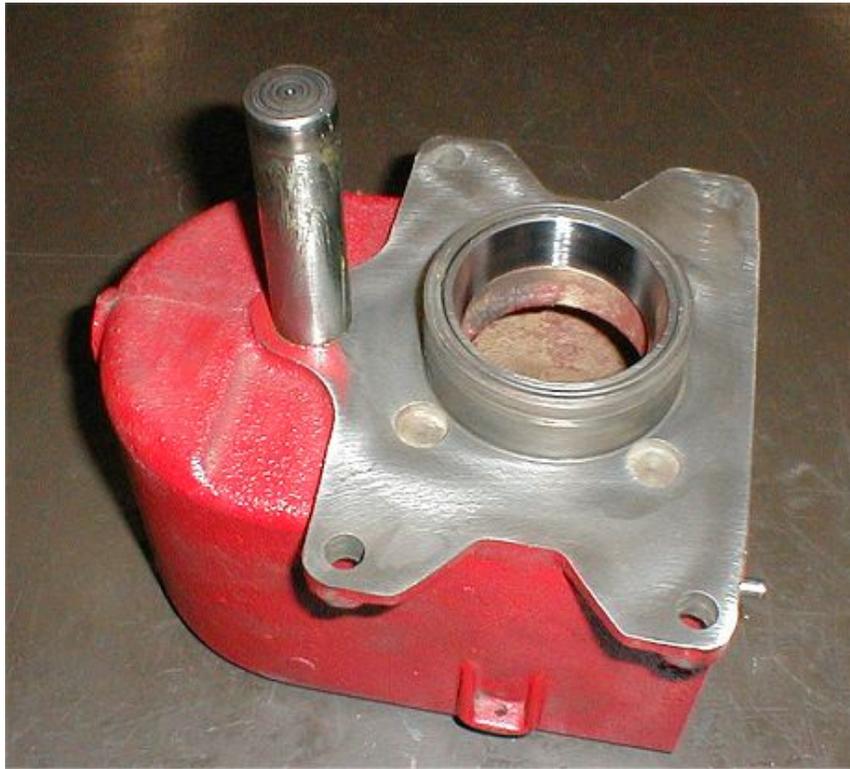
Be sure to have everything lined up as the countershaft goes in. The last 1/2" or so is a press fit.

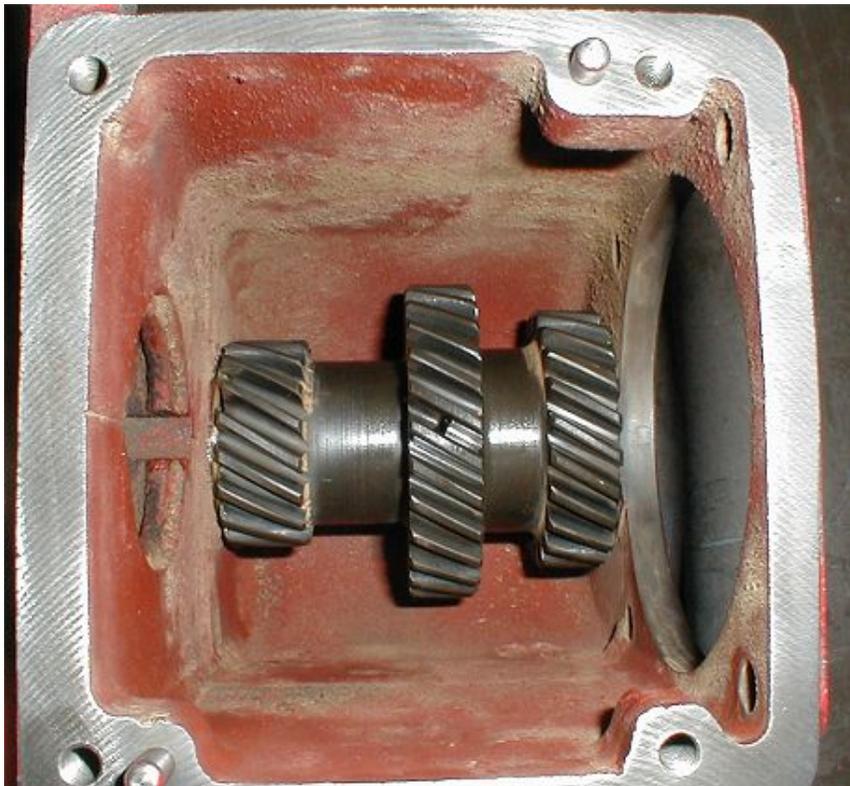
Once the cluster gear is installed make sure it turns freely and check end play with a feeler gauge. It should be at least .005" and no more than .025". If it has too much end play you need new thrust washers.

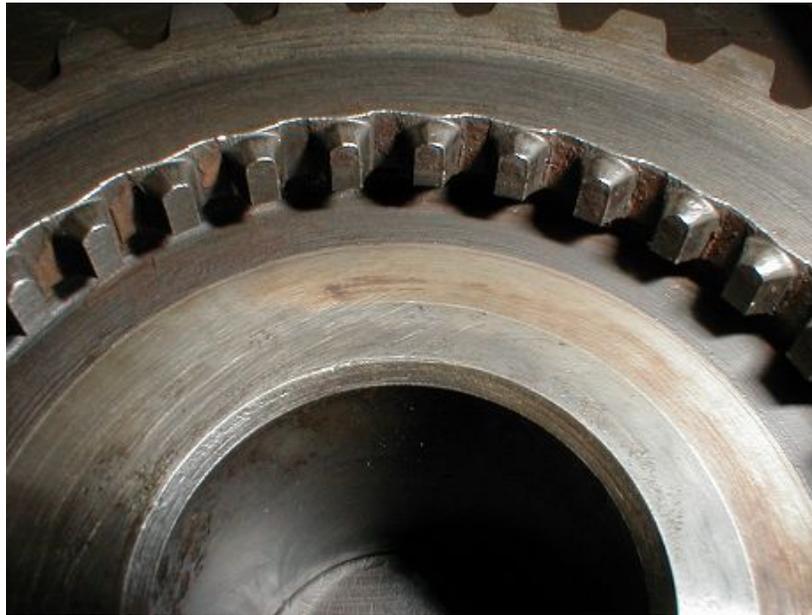
Next, closely inspect the step-down gear. Make sure there are no chips or abnormal wear on the gear teeth and no wear or rough spots in the bore. Since this gear spins with a metal to metal contact on the output shaft it must be a good fit and have a smooth surface inside the bore. Then check the dentals on the front side where the sliding collar engages with the step-down gear. They should look just like the ones in this photo. Any abnormal wear or damage to the dentals will result in a transmission that jumps out of gear under a load. See the photos below of the sliding collars for examples of abnormal wear on the dentals.

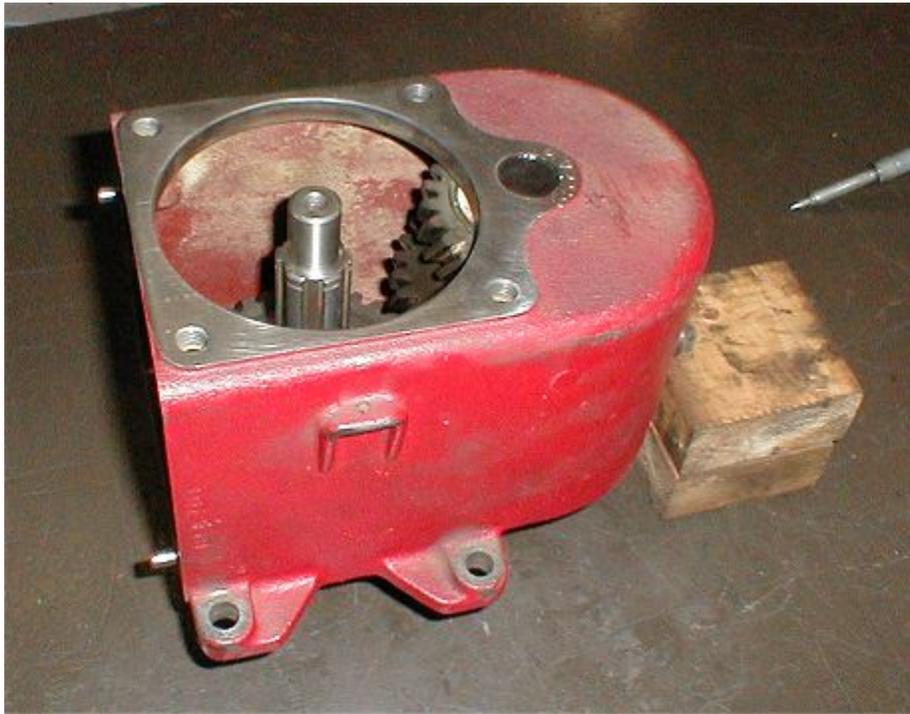
Lower the case with the step-down gear down over the output shaft and use a wood block or other suitable item to support the bottom end so it sits flat on the bench as shown.

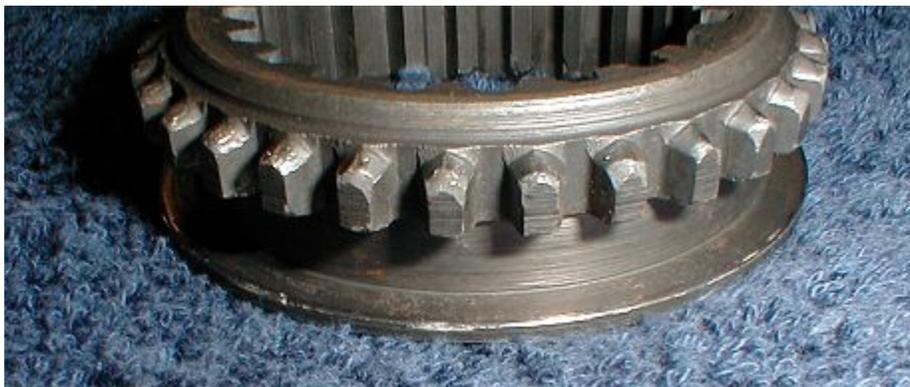
Next is the extremely important inspection of the sliding collars. The sliding collars must be in good shape or the Sherman will not stay in gear. While the two sliding collars may look alike at first glance, they are not alike. Don't mix them up when assembling. The dentals on the collar in this photo are chipped on the ends, probably from someone trying to shift gears without stopping the tractor first. The sides of the dentals still look pretty good. While it's not the best, one like this would probably work ok if you can't locate a better one.

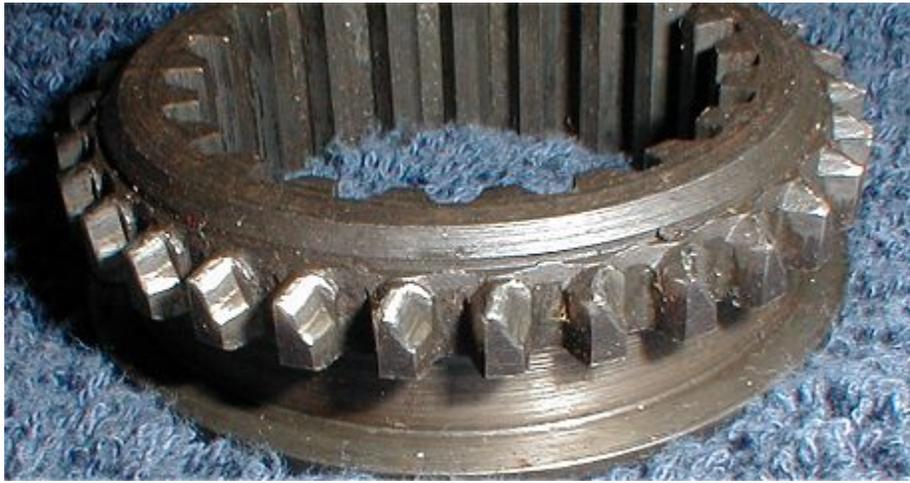
The dentals on this collar are badly worn and came from a transmission that would not stay in gear. You can easily see why. This collar is junk along with the step-down gear it mated with.

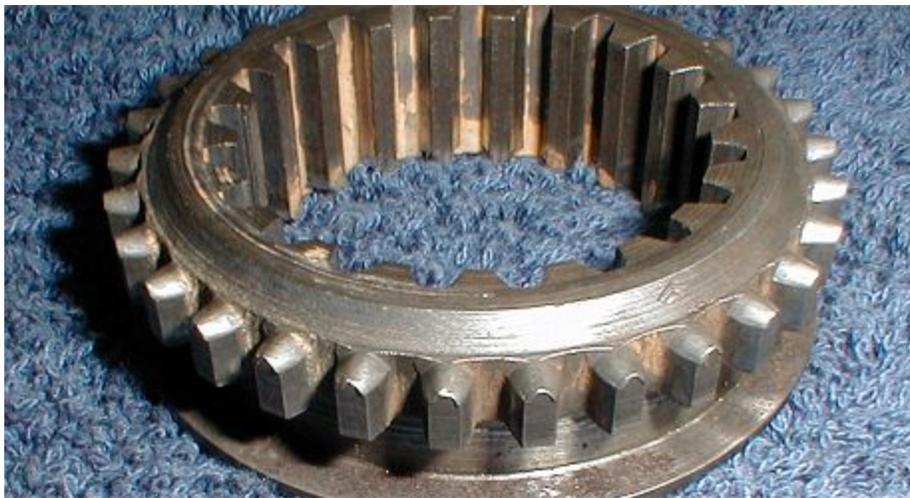
The dentals on the outside of this collar are excellent, just like new. We'll use this one.

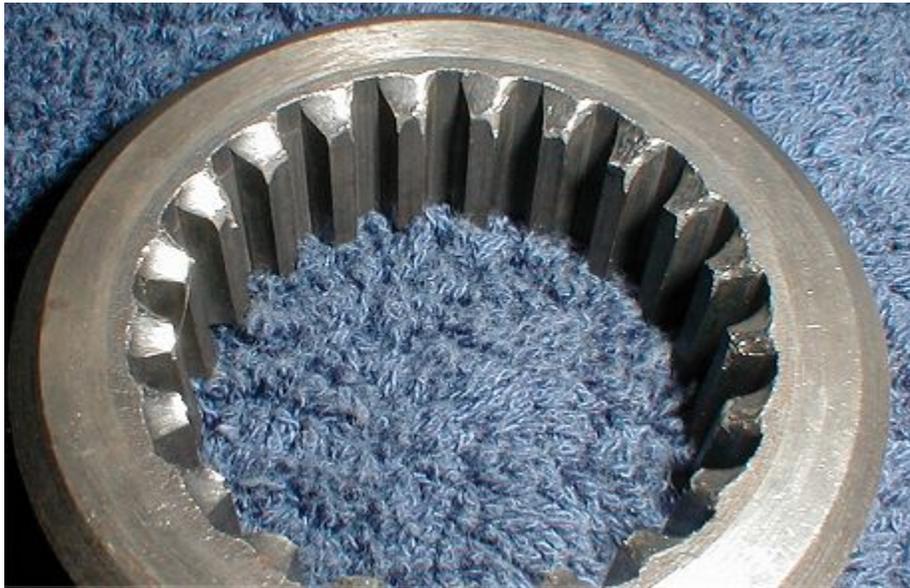
The rear sliding collar (hi/lo) engages the step-down gear on the outside dentals and engages the step-up gear on the inside of the opposite end. This collar shows badly worn inside splines. It's junk, as is the step-up gear it mated with.

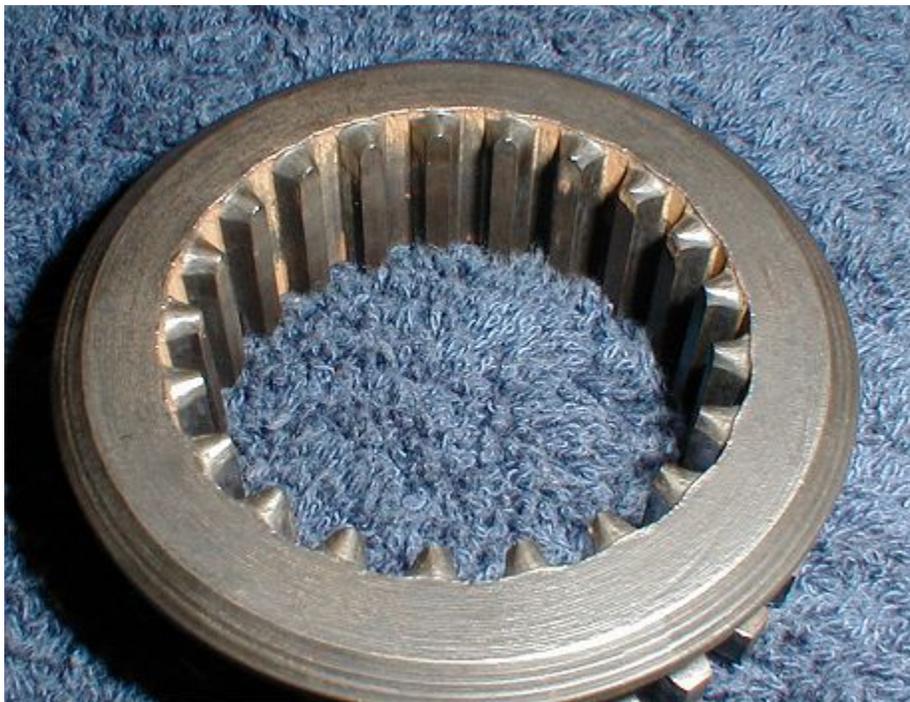
A good one looks like this which shows almost no wear and is nearly perfect. We'll use this one.

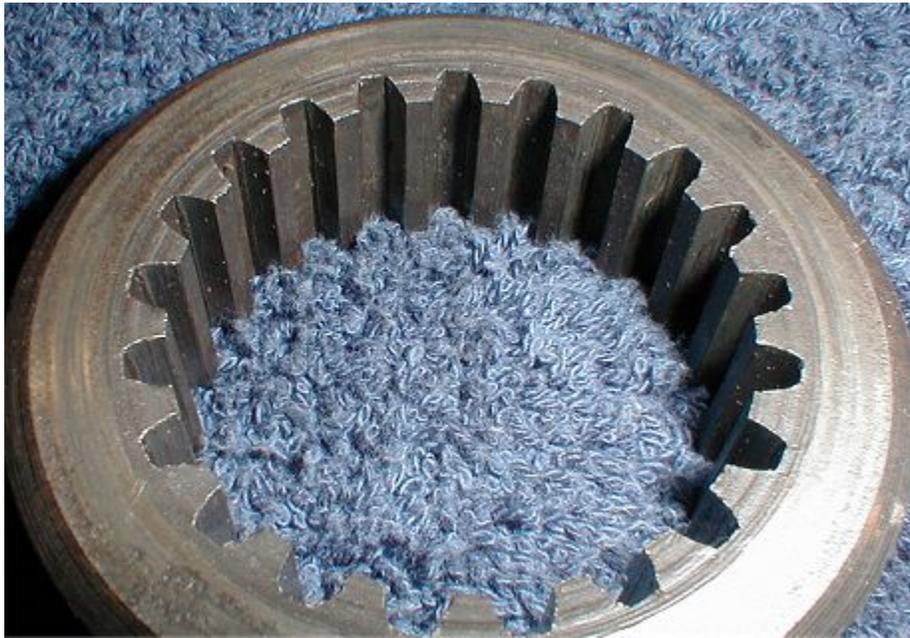
The front sliding collar (direct) has no dental chamfers on the inside splines because it only mates to the front input shaft with the external dentals.

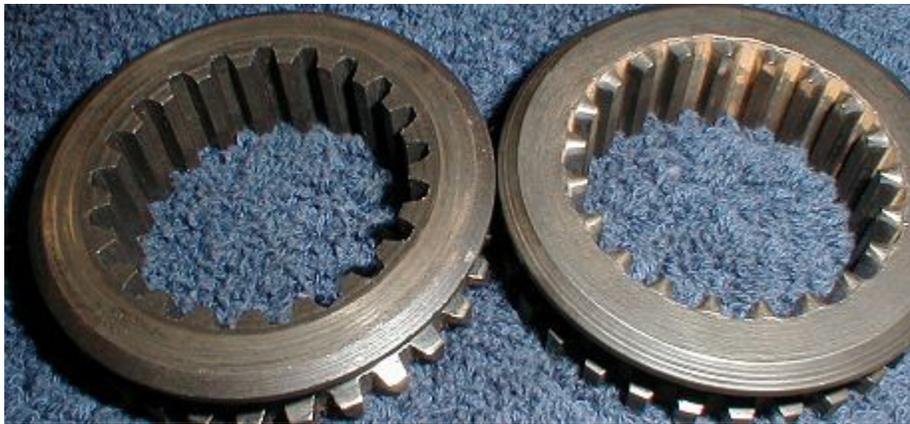
A glance at the inside splines will tell you which collar is which. The one on the right is the rear hi/lo collar.

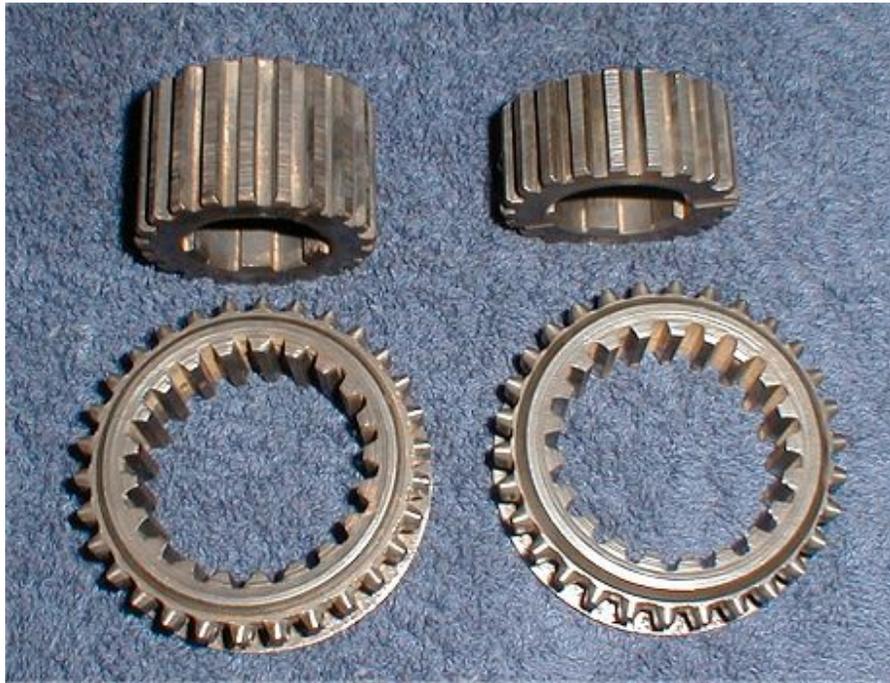
The hubs for the sliding collars are also different. The longer hub is for the rear collar and the shorter one is for the front collar.

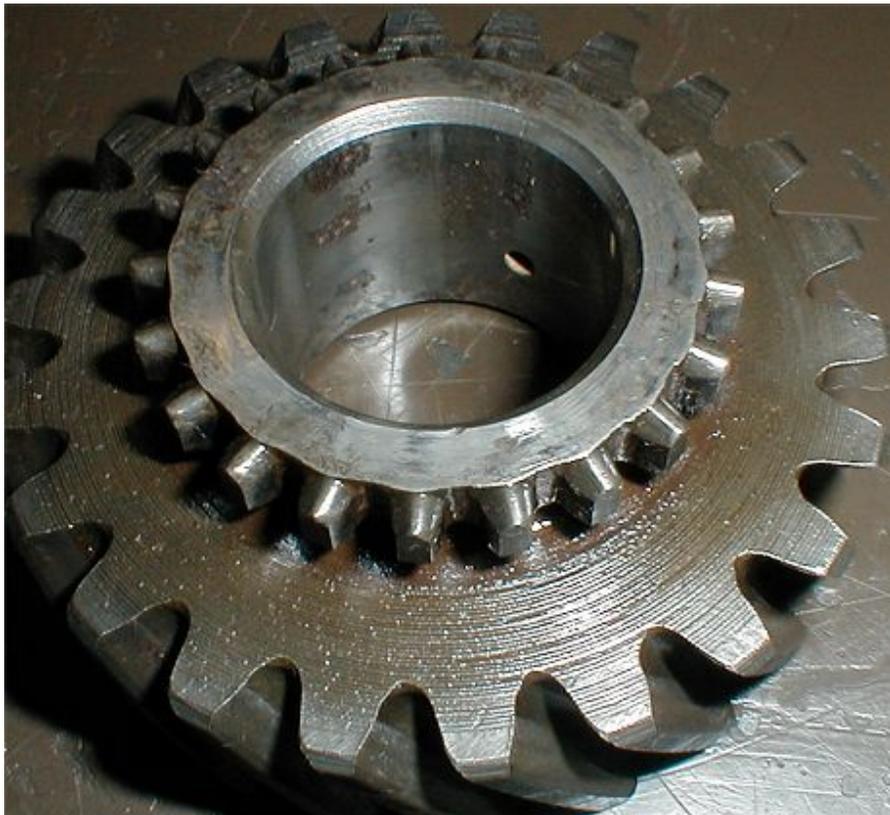
Next we inspect the step-up gear. The dentals should look like these which are in excellent condition. The bore should be smooth and round and be a good fit to the output shaft. This bore is very good but has a couple of tiny rust pits. We will chuck it up in the lathe and polish it lightly with a fine emery paper before installing it.
