Rebuilding a Sherman Combination Transmission by John Smith (<http://www.oldfordtractors.com/screbuild.htm>)

SHERMAN STEP-UP AND STEP-DOWN COMBINATION TRANSMISSION

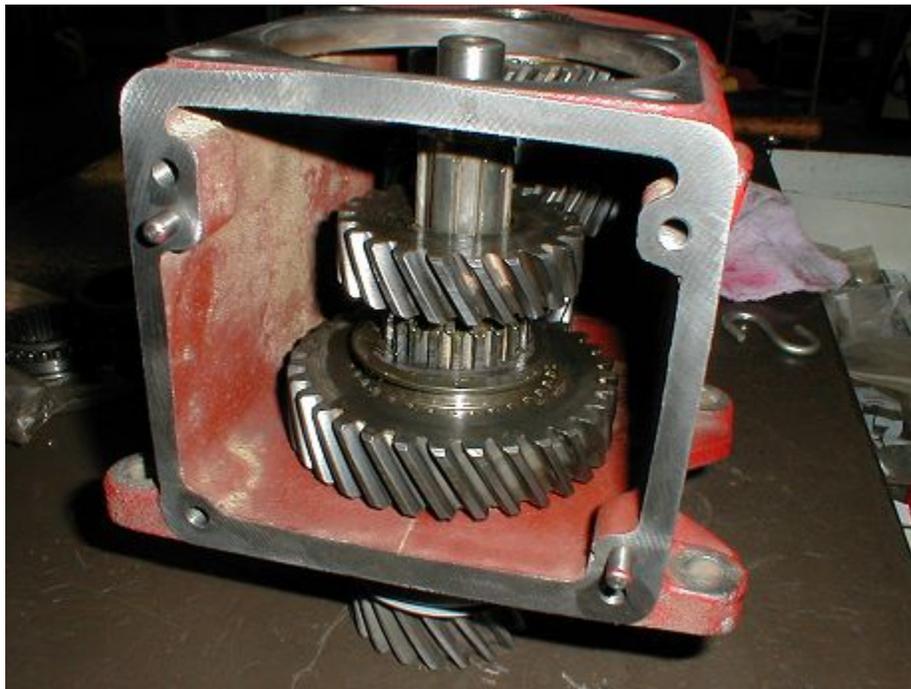
Place the longer hub and the rear sliding collar over the output shaft in the case. Next, install the step-up gear onto the shaft, dentals to the rear. You should be able to slide the collar freely between the step-down and step-up gears and engage either one.

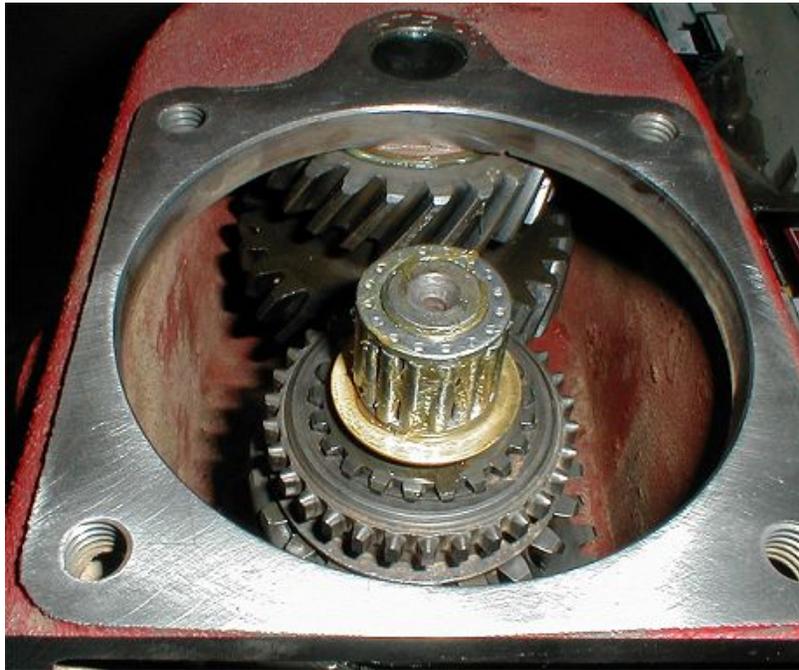
Install the brass washer and a new needle bearing and we're ready for the front input (clutch) shaft.

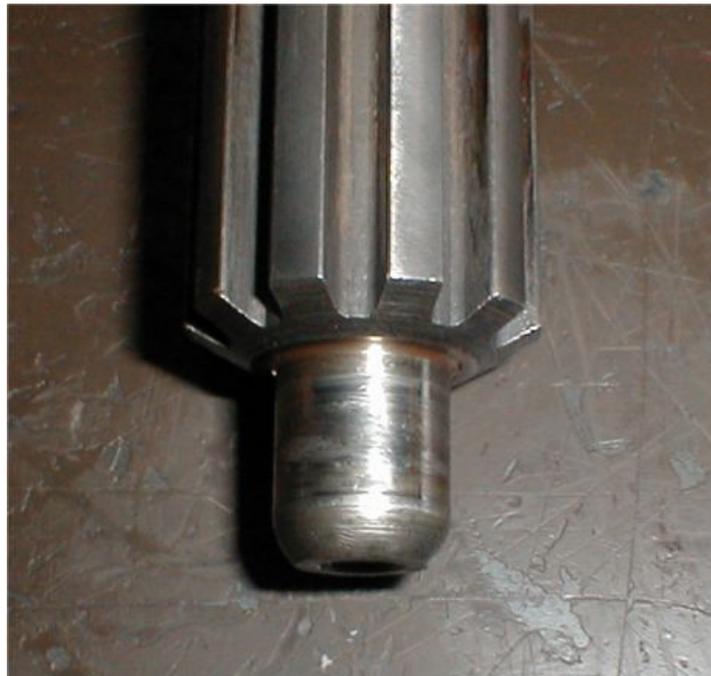
The front end of the clutch shaft is supported by the pilot bearing in the flywheel. If the pilot bearing goes bad it can wear the bearing diameter badly on the input shaft and you'll need to replace the input shaft or repair the bearing diameter. This one shows signs that it has spun inside the pilot bearing at some time or other but it has no measurable wear and will be just fine. Check the clutch splines for wear also. The clutch splines on this one look like new.

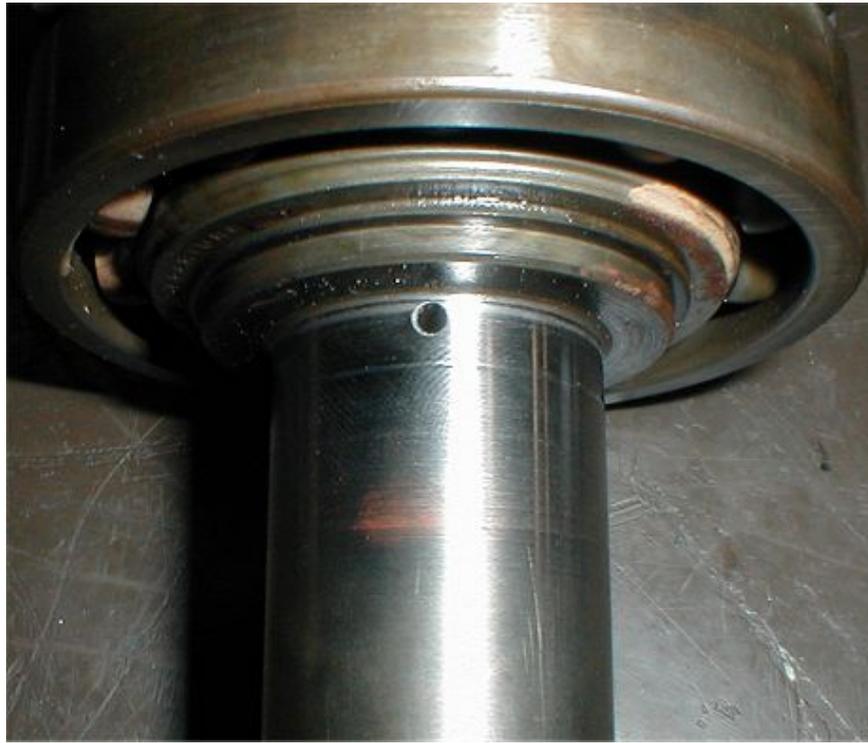
Next, check the seal diameter on the shaft. It should have no measurable grooves or wear. If it does, the seal will never be able to keep the oil in. This one has just a very slight line where the seal rides. It's good.

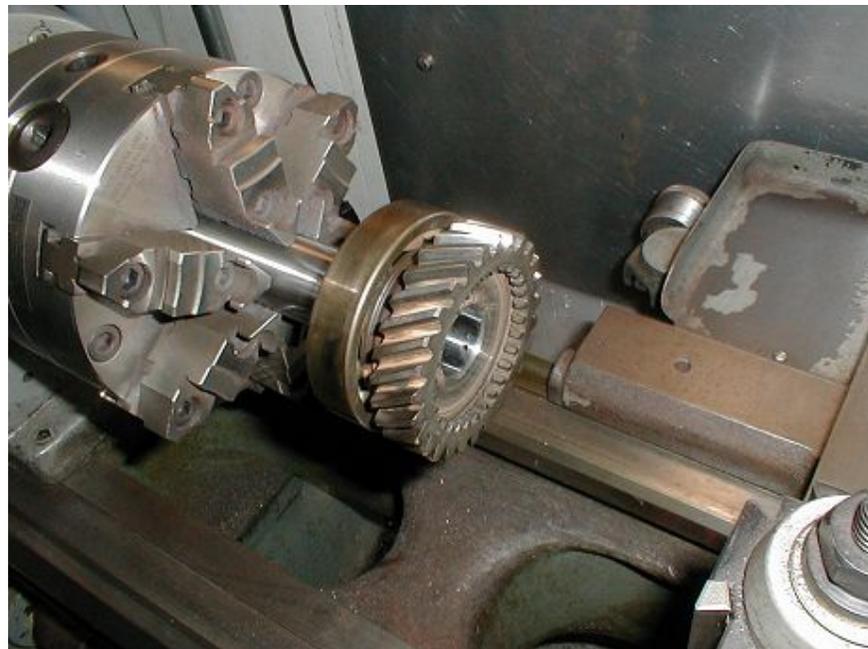
Check the dentals closely on the inside rear of the input shaft gear just like we did for the dentals on the step-down gear. These dentals engage with the front sliding collar for the direct range on the Sherman. Also inspect the bore in the back of the gear. The mainshaft needle bearing rides in this bore and it has to be good. Here we've lightly polished the bore to remove some rust staining.

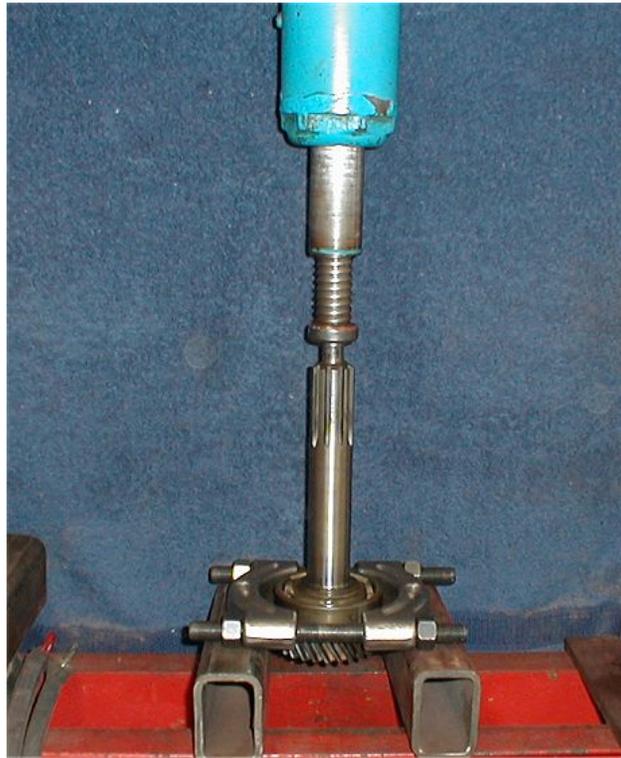
Remove the snap ring and press the old bearing off the input shaft if it needs replaced (they nearly always should be replaced).

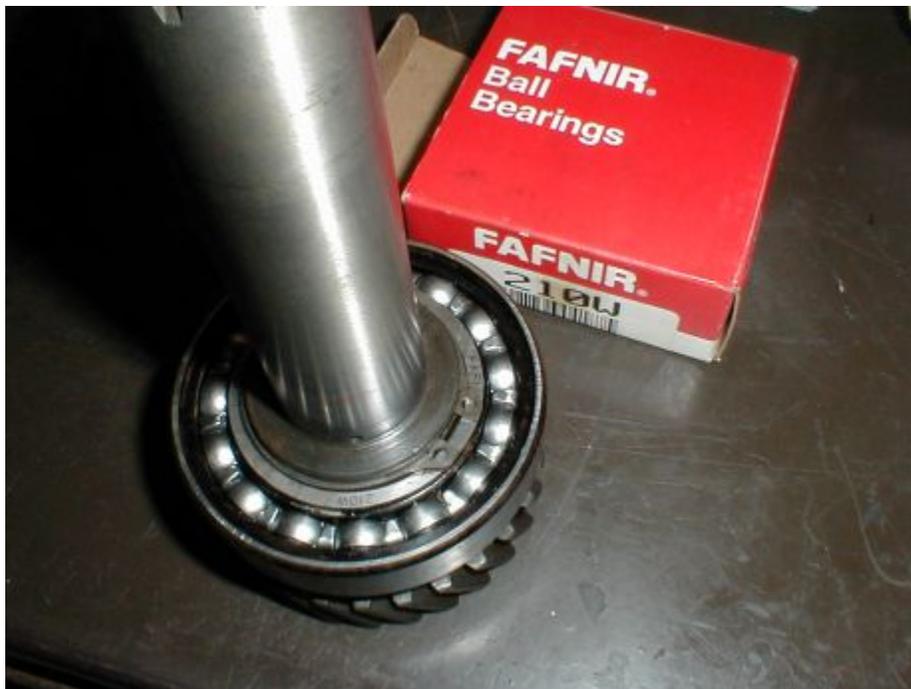
Press the new bearing on and replace the snap ring. Always use the heavy duty version of the bearing here and not the standard duty. The heavy duty bearing has more balls to carry the heavy radial load from the input shaft.

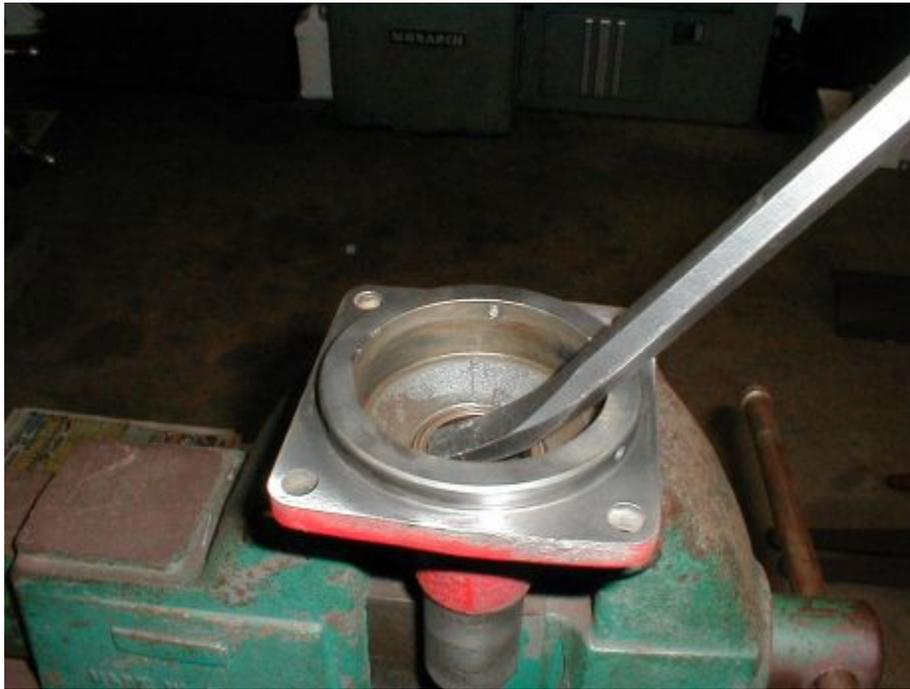
Remove the old seal from the nose cone with an inside puller or a pry bar.

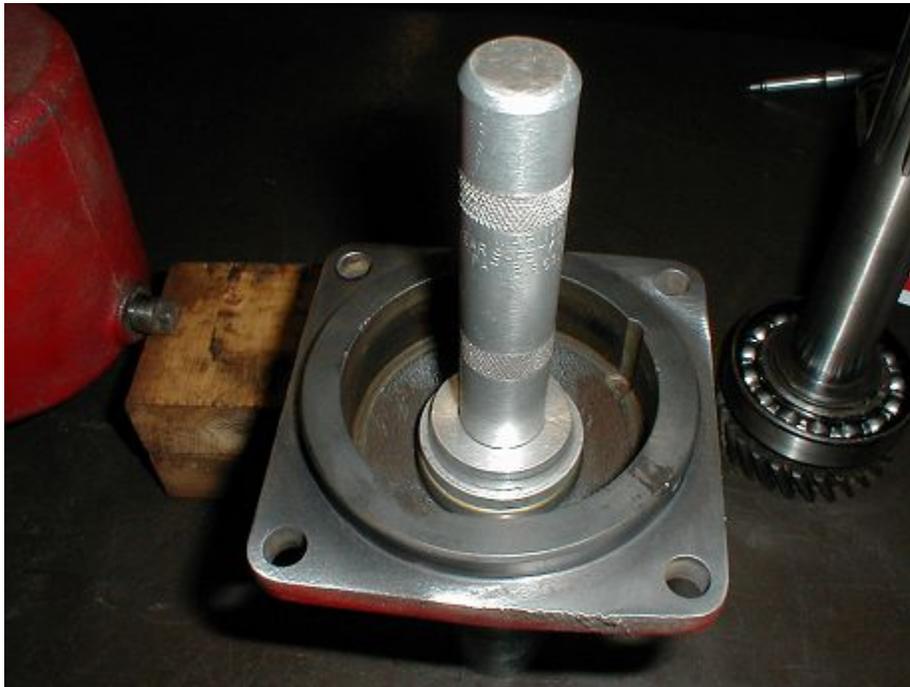
Install the new seal with a suitable driver. The seal lip goes toward the inside of the case.

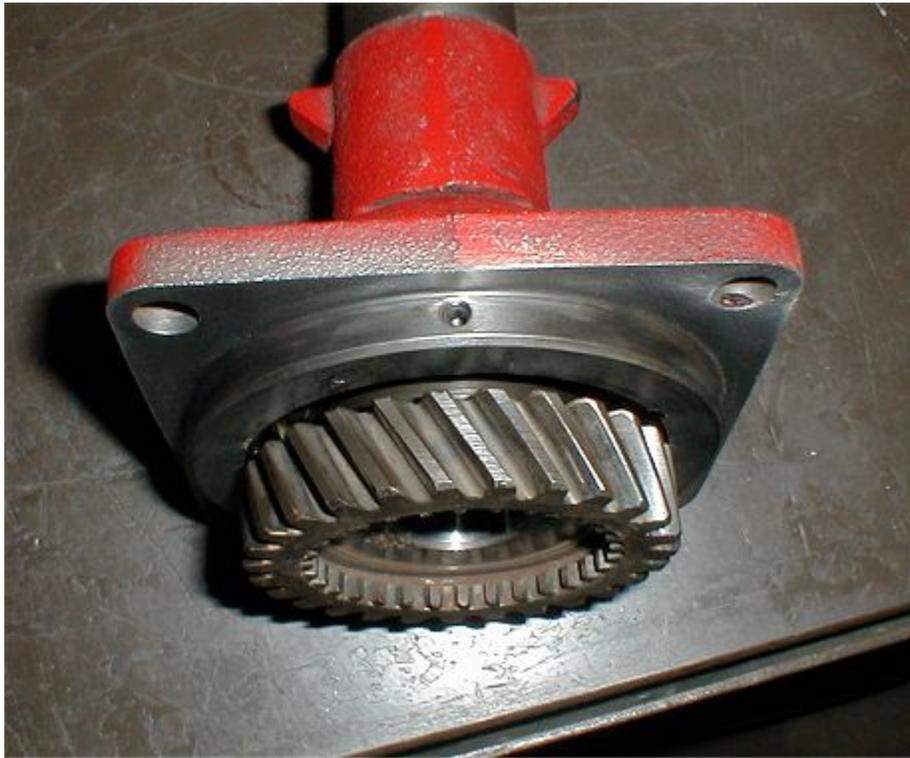
Install the input shaft into the front nose cone. Make sure the bearing seats all the way into the pocket.

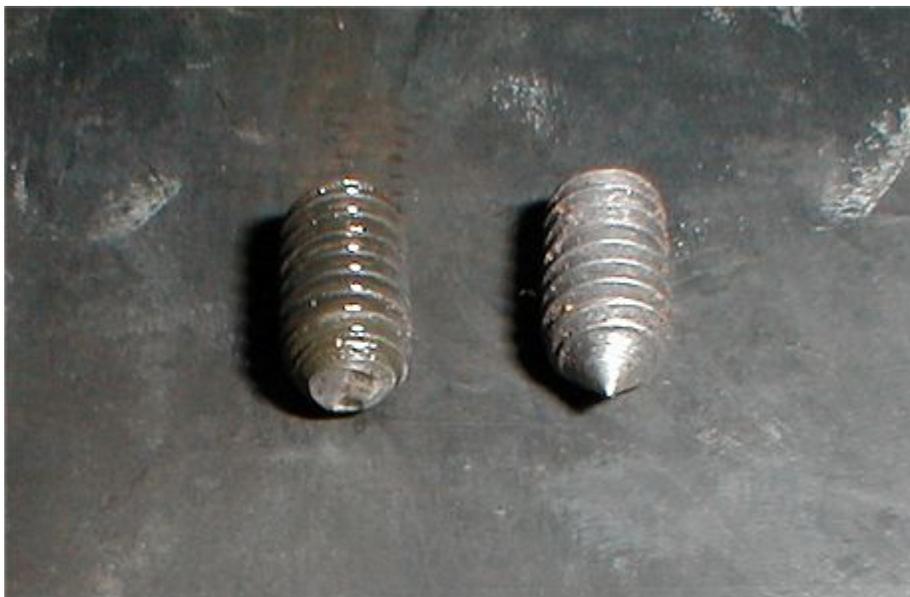
Install the 3 set screws that keep the bearing in place in the nose cone. Inspect them to be sure the cone point is still intact like the one on the right in this photo. If the point is sheared off like the one on the left the set screw needs replaced. The point is the only thing that holds the bearing in place as it protrudes just above the outer bearing race. Do not tighten these set screws more than "snug" as you can distort the bearing race and cause premature bearing failure by over tightening.

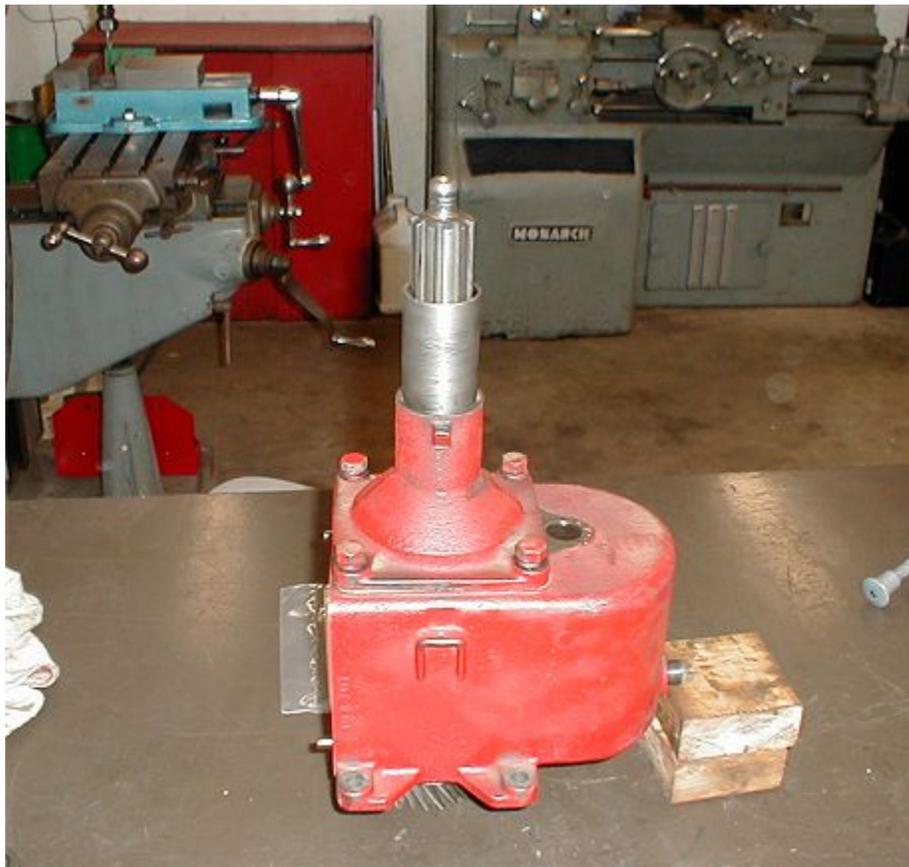
Put a new gasket on the flange and install the nose cone and input shaft onto the case.

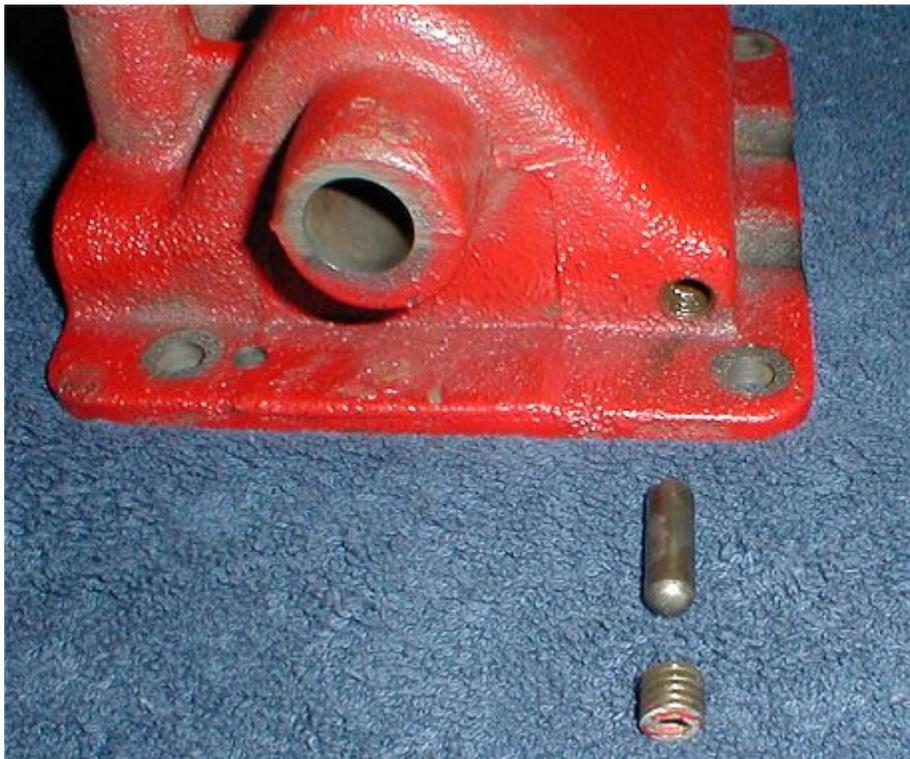
Remove the set screw on the side of the cover and slide the interlock pin out.

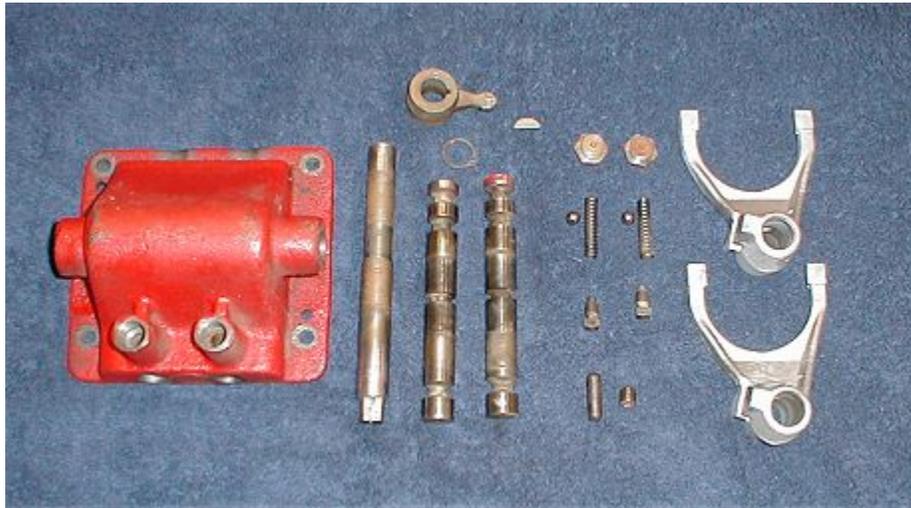
The disassembled top cover and all the parts.

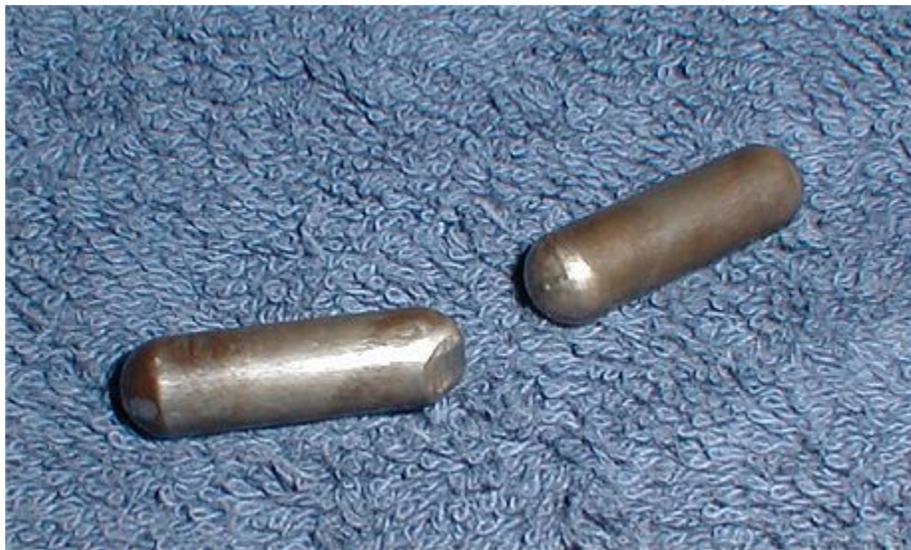
Check the interlock pin. Both ends should be round like half a ball and smooth, not gouged or sheared like the one on the left in this photo. If it's bad, replace it. This pin is what keeps the transmission from going into 2 gears at once. When you shift one rail, the pin slides over and locks the other rail in the neutral position. Lubricate it with some 90w gear lube and install it back in its bore, making sure it slides freely from side to side.

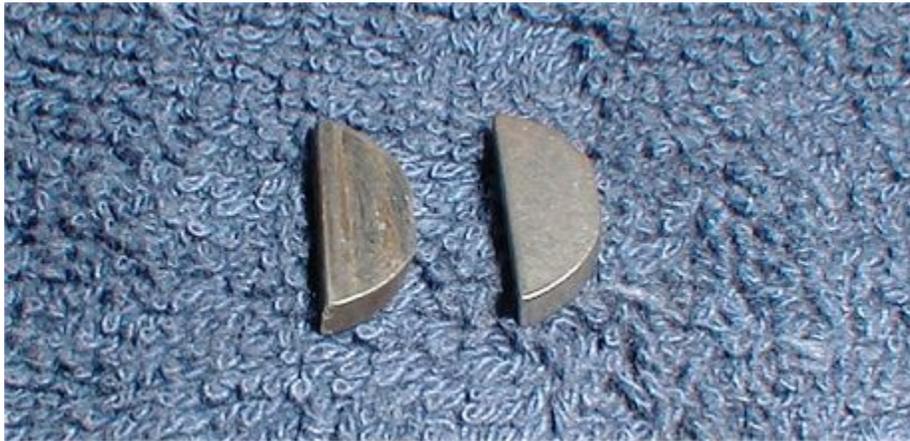
Replace the Woodruff key. The key always wears on the sides and a little bit of wear on the key translates to a lot of play at the end of the shifter lever.

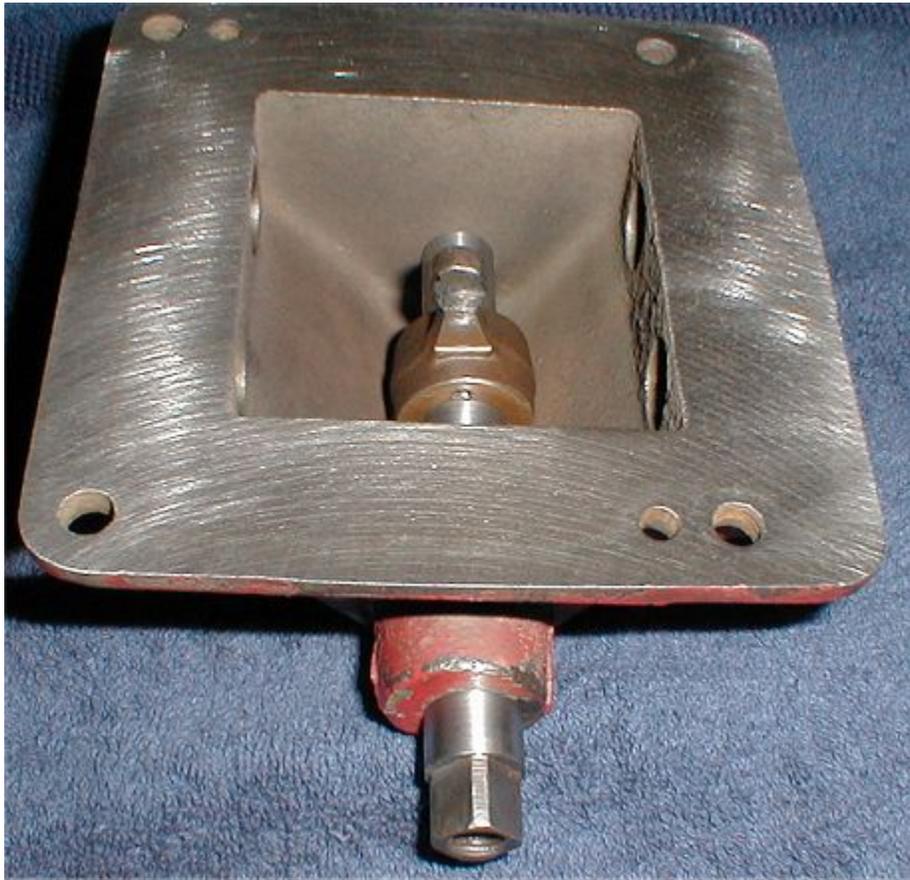
Install the shifter shaft, key, shifter finger and snap ring back into the top cover. Make sure the shifter shaft moves freely back and forth and rotates freely side to side. Lube everything with 90w gear lube when assembling. Removing and installing the snap ring is easier with a set of snap ring pliers with a 45 degree bent nose.

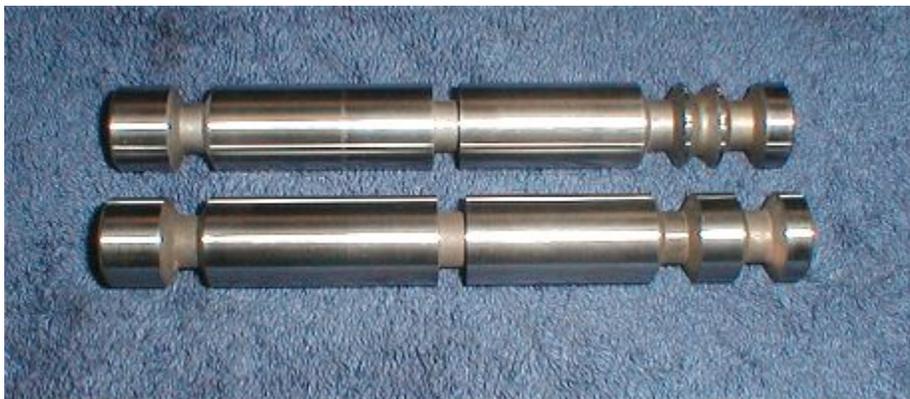
The two types of shift rails are shown here. On top is the later rail that has a detent for the neutral position (a nice addition). The lower one is the early style. Polish the rails and inspect for straightness and any damage such as rust pitting, scoring or galling. Watch for grooves from the detent ball wearing into the rail.

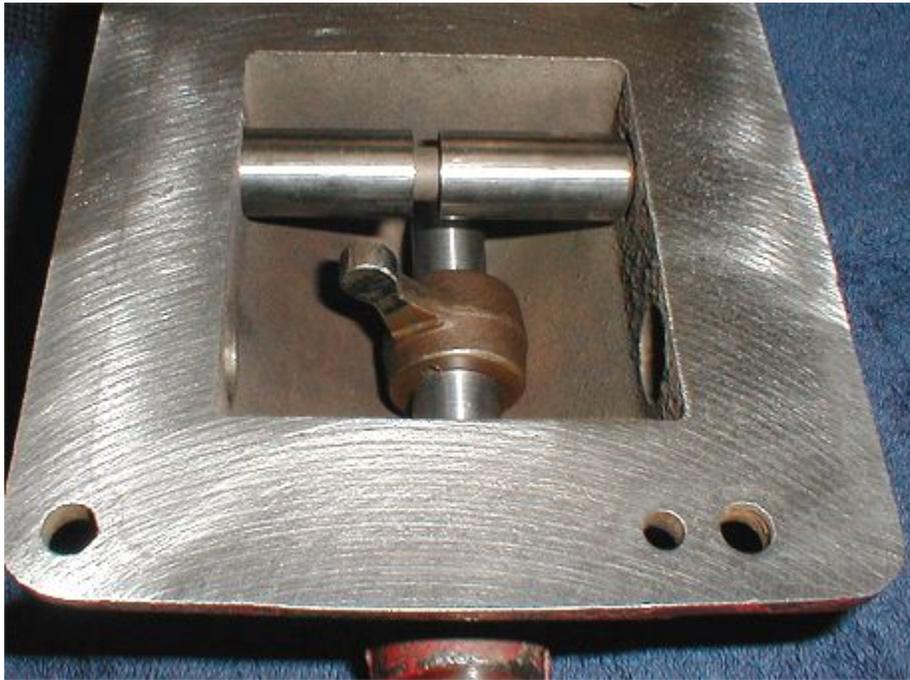
Slide both rails into the top cover and make sure they work freely back and forth and rotate without any binding or tight spots which could indicate a bent rail. Remember the single groove end of the rail is for the interlock pin and the 2 or 3 groove end is installed under the detent ball towers.

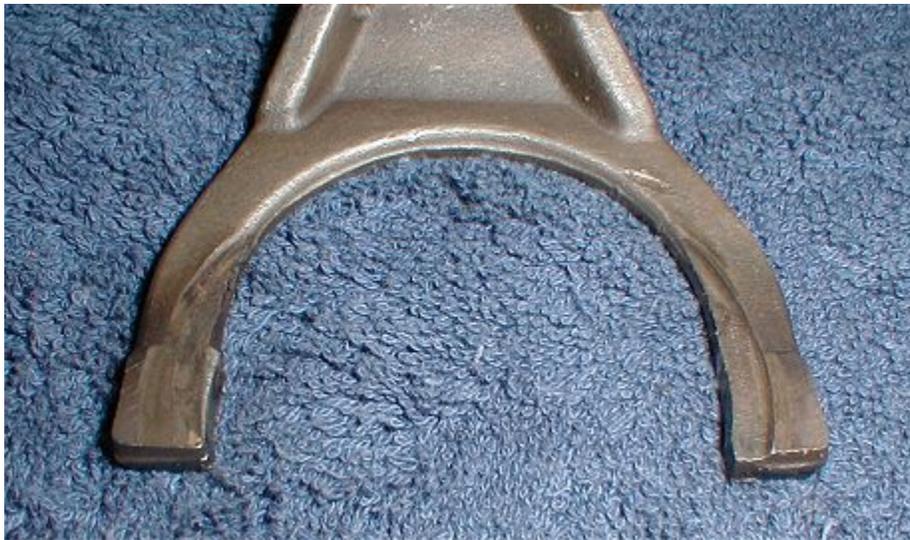
Inspect the shifter forks for cracks, straightness and wear. The fork above is badly worn. It's junk. Do not try to use something that looks like this one in your Sherman.

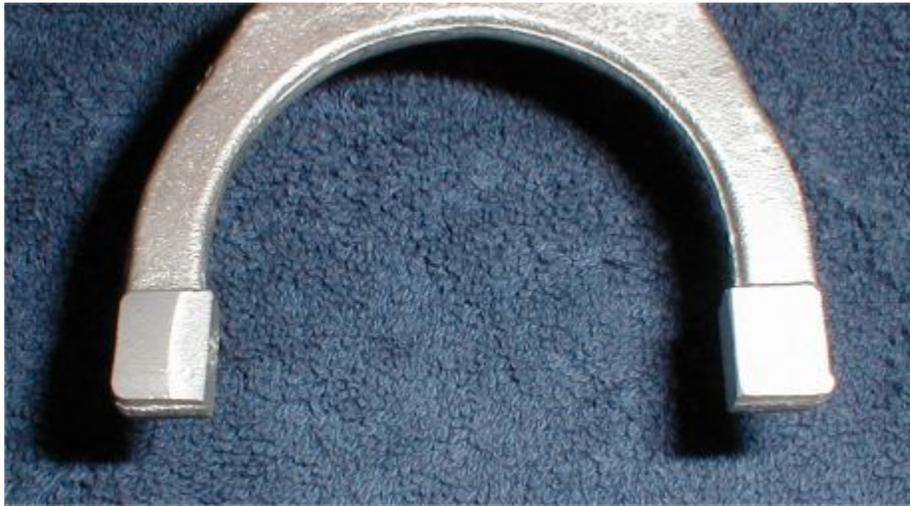
This is a forged steel fork used in the earlier Shermans. It's in very good condition with only the slightest sign of wear.

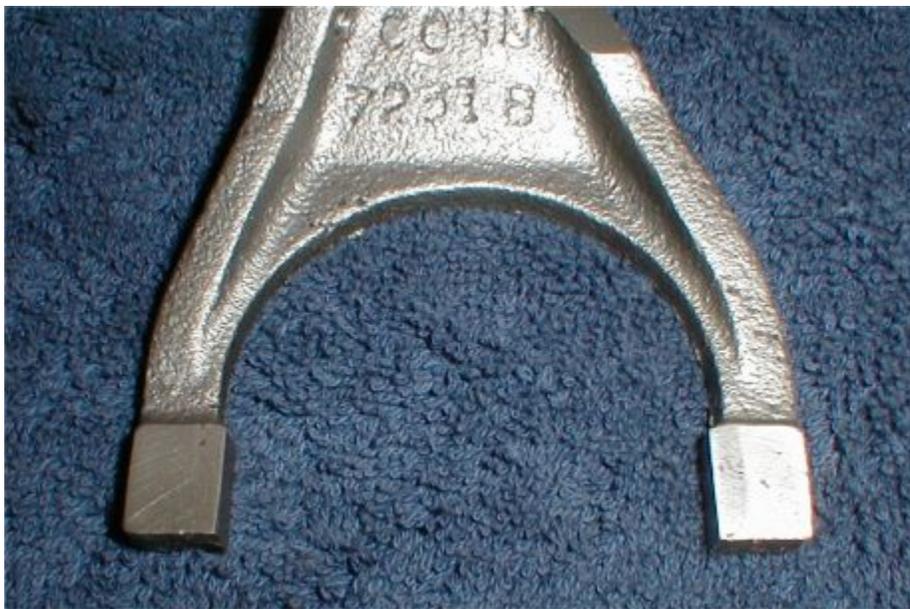
This is a later style cast steel fork from a Ford built Sherman. They are interchangeable with the early style. This one is also in excellent condition with almost no wear at all.

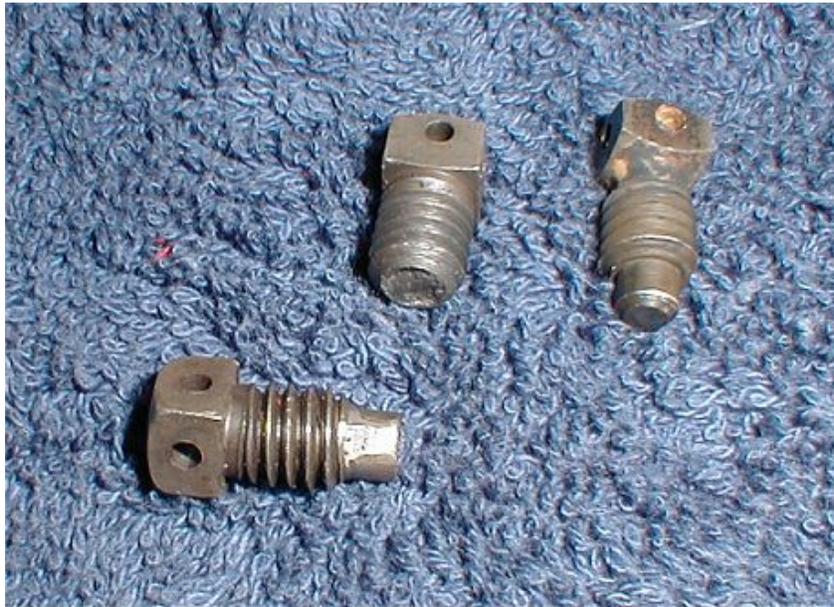
This is the dog point set screw that keeps the shifter fork lined up with the small groove in the center of the shift rail. It's this little guy that causes a lot of shifting problems. Only the shear strength of the dog point on the set screw keeps things aligned and they can shear off as you can see on the one in this photo. Make sure the dog point is good, not worn on the sides or bent or broken. Replace with new ones if there is any doubt. If one of these dog points shears off, the shifter fork will move with the lever but the rail will not and the interlock will effectively block your other gear range until you replace the set screw. The one on the right is good.

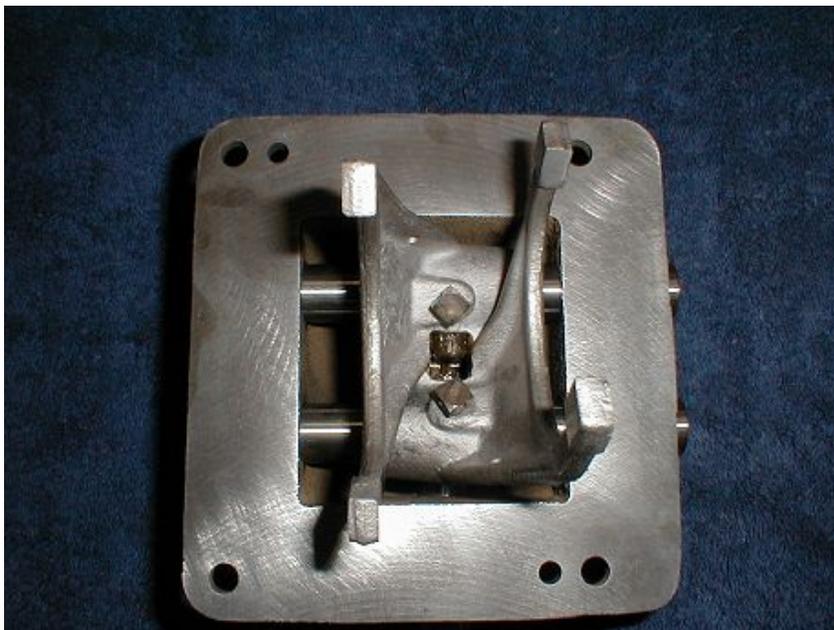
Place the shifter forks into the cover, slide the rails into the forks, align the center groove in the rail with the set screw holes, and install the set screws finger tight. Turn the set screws until snug then back them off slightly until the fork moves freely side to side without the rail rotating. The fork must be retained to the rail by the dog point only and not by pressure from the screw. Do NOT tighten the set screws with a wrench.

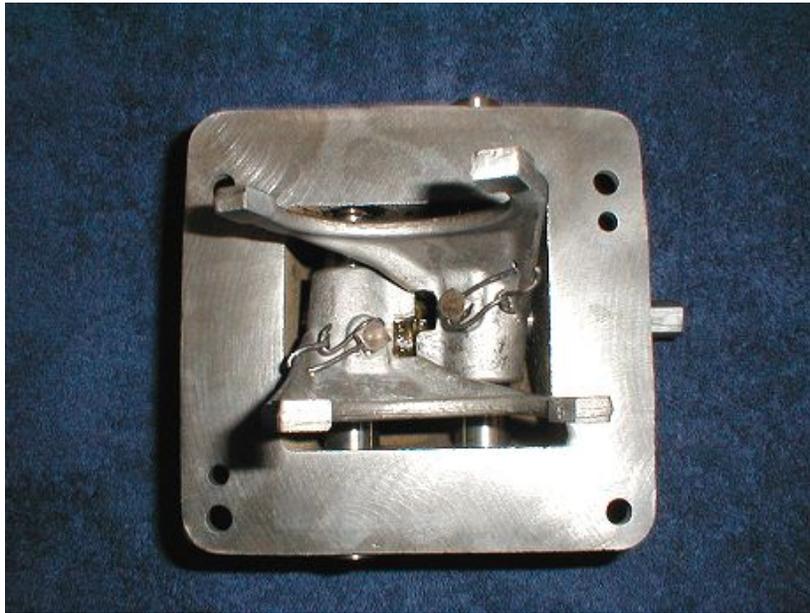
Once the set screws are where they belong use safety wire to keep them in place. You should now be able to shift the forks through the 3 different gear positions and everything should move smoothly and easily.

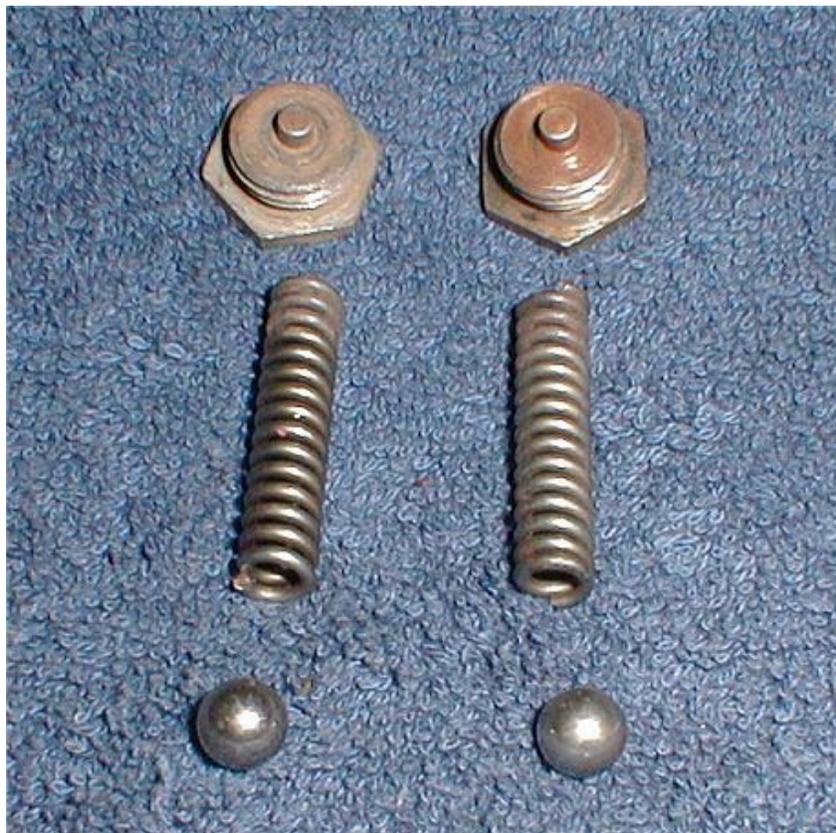
Inspect the detent springs for breakage or mushrooming on the ends and replace them if needed. The detent balls get rusty and develop flat spots. Always replace them - they only cost a few cents each. Be sure to lube the detent tower bores and the balls and springs with 90w gear lube when you install them.

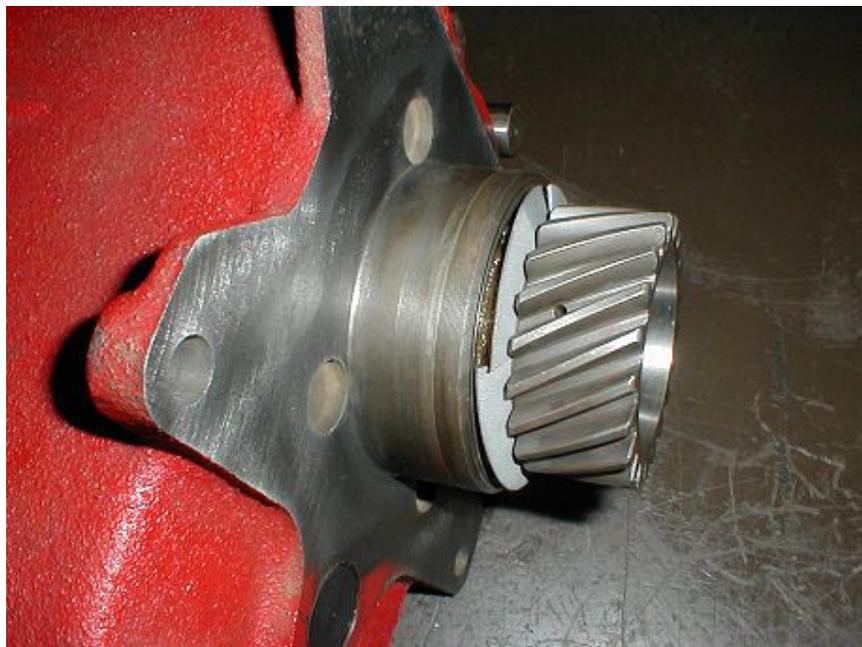
With the output shaft held in place be sure the oil slinger is not rubbing on the case. It can be gently "adjusted" for clearance if necessary.

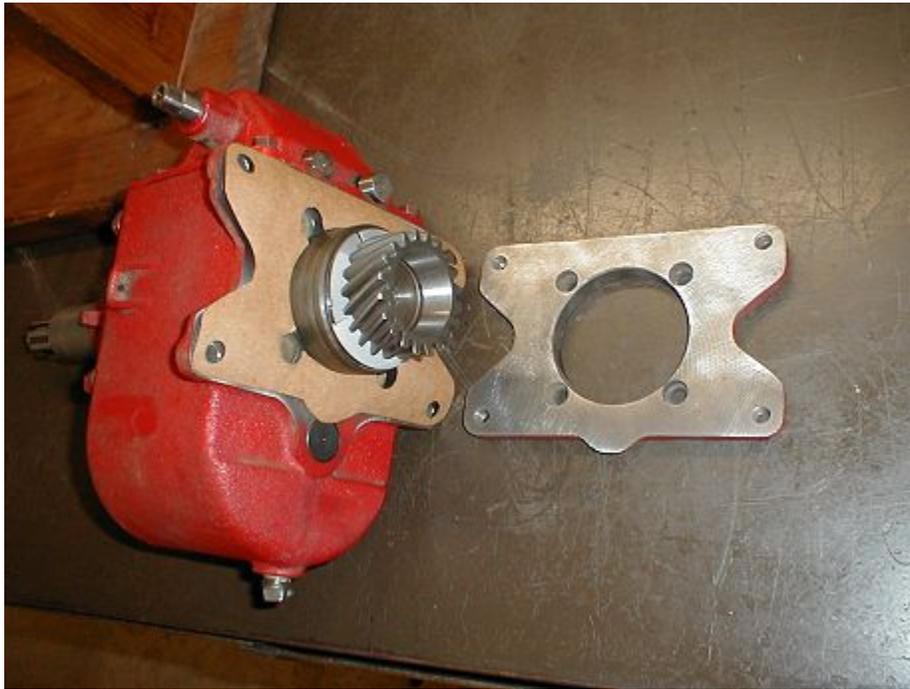
The last item is a new gasket for the mounting plate surface. Make this gasket from 1/64" gasket material. Be sure to check the mounting plate for flatness and for cracked or stripped threads.
