# Restoring the Aluminum Hood for 9N292

**By: Stephan Dabrowski**

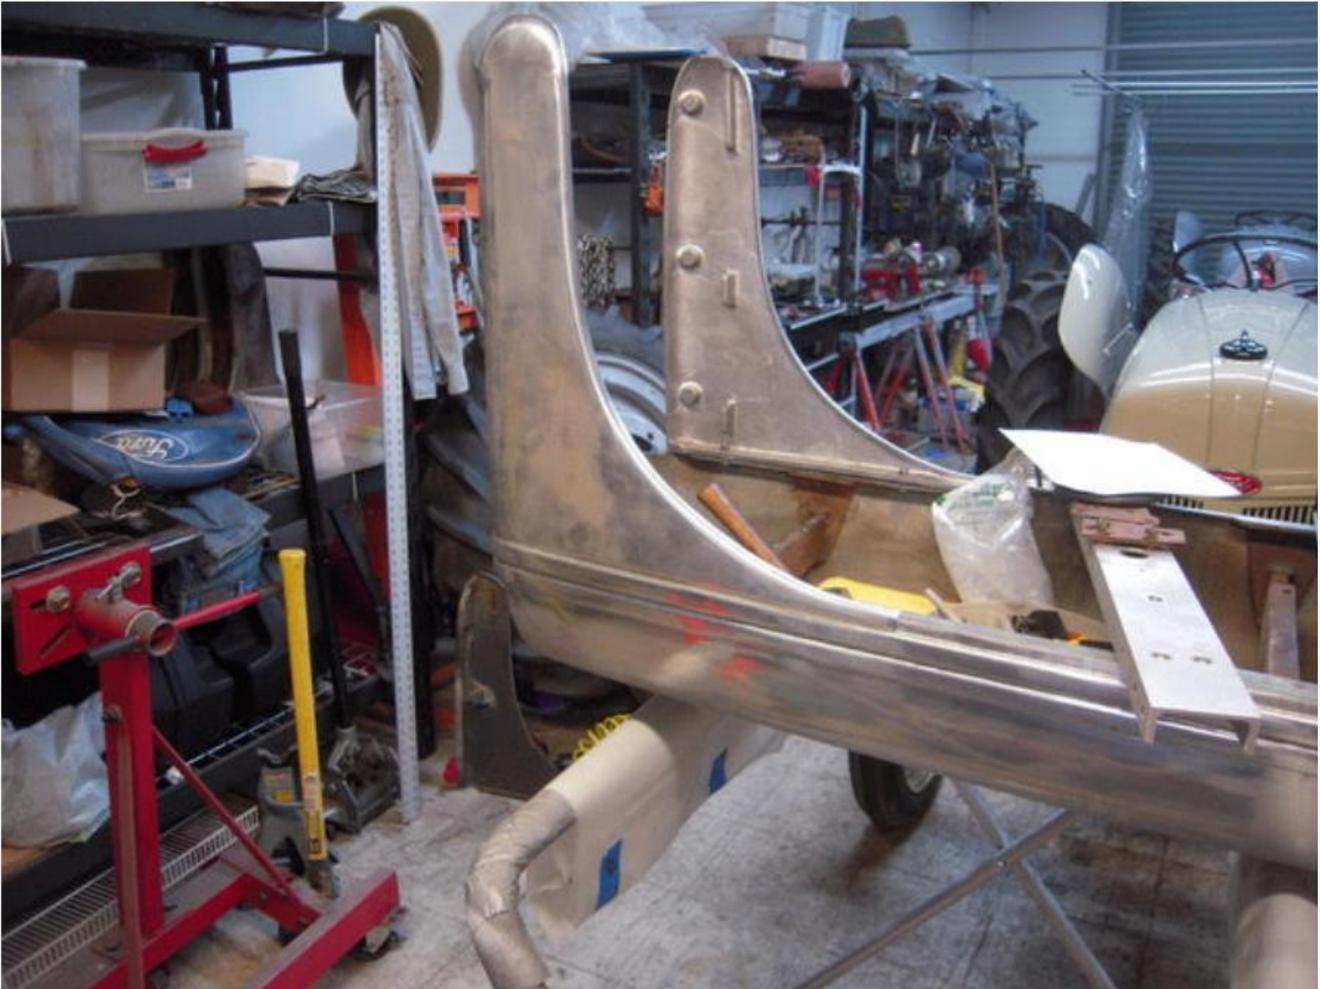
Hood with dog legs in place before any serious machining. The tabs seen here still required milling to flatten and drill and tap for the grill. The grill required drilling to match tabs and to properly fit for width. Quite a bit of work and trial fitting to get right.

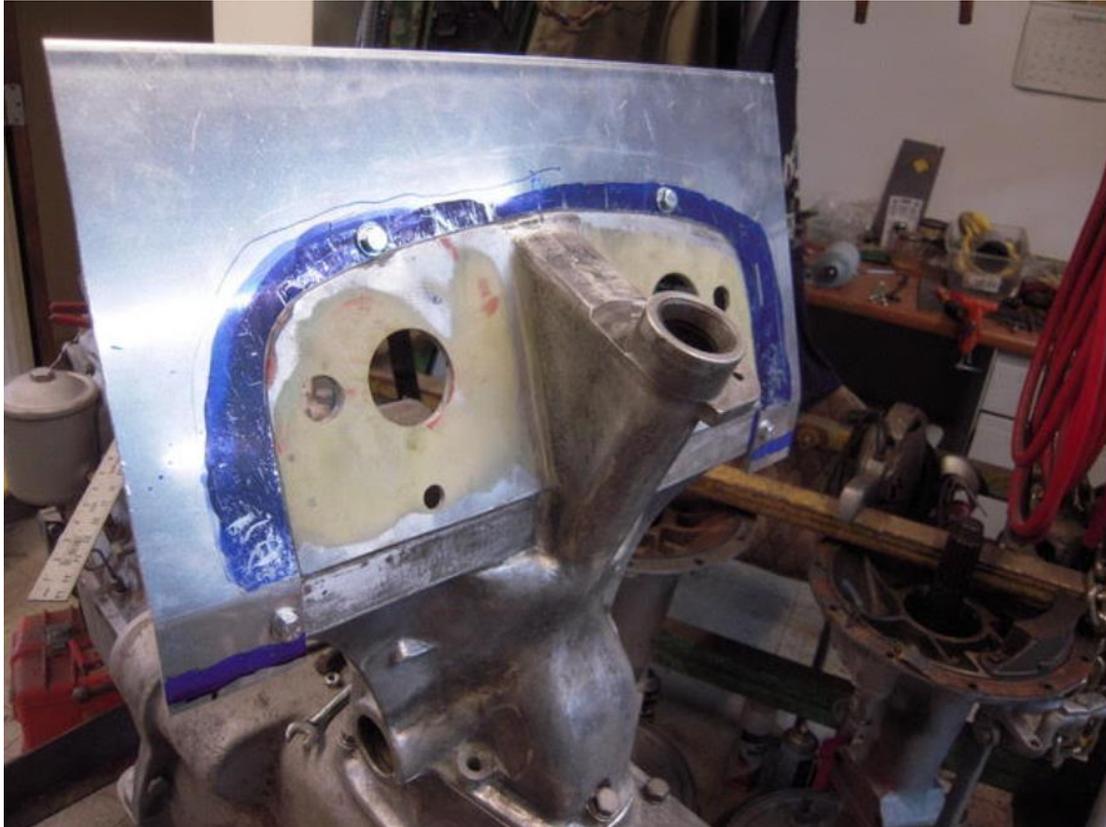
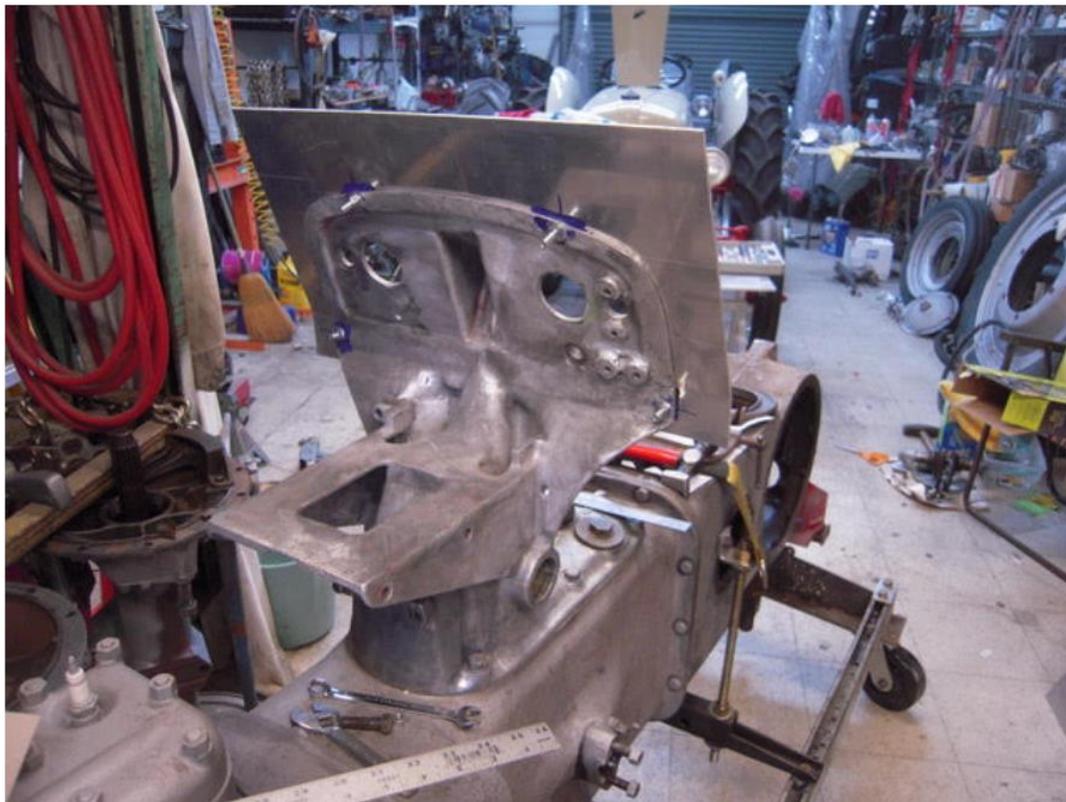
The rear section of the hood needed to be completely replaced as it was oriented in a cocked manner that prevented it from mounting without a large gap on one side. I used a flat plate of 1/8" 5000 Aluminum sheet that I cut and drilled to match the dash.

In order to fit this to the hood I had to cut away the majority of the hood rear section and cut this to match the cutaway portion of the rear hood. I used the dash mounted in place on the hood using a pair of 1-5/8" unistrut sections with 1/8" plates bolted to the bottom edge of the hood and the battery surface of the dash. It required exact centering that I accomplished using a string from the front center of the hood to the steering post and a square to align it with the center bolt hole attaching the dash to the transmission top plate. A very tedious job.

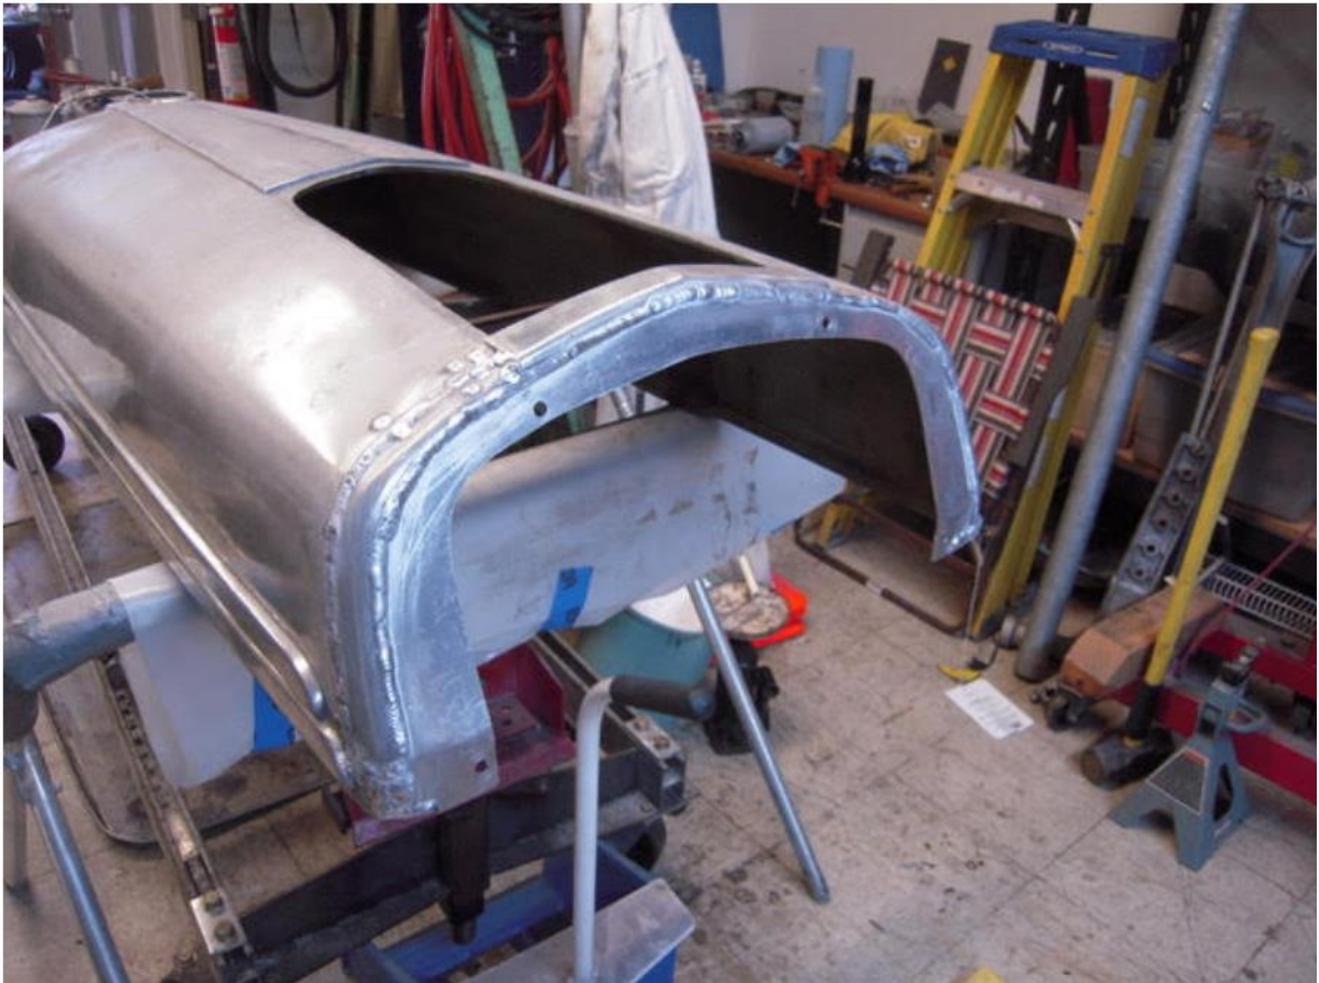
The result of the welding. I had to take a slim section out of the left side of the hood to make it properly square as can be seen in this photo. That was a real scary part, and I cannot explain why it was necessary, but it was.

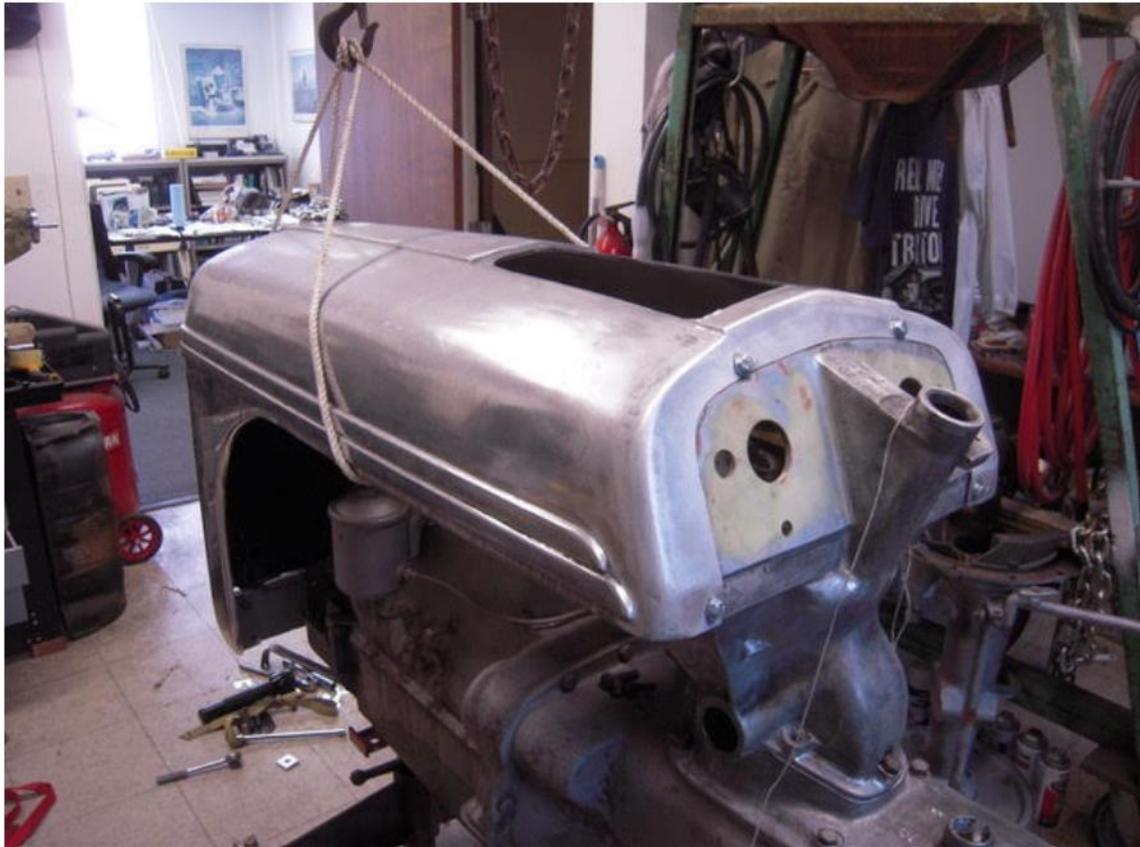
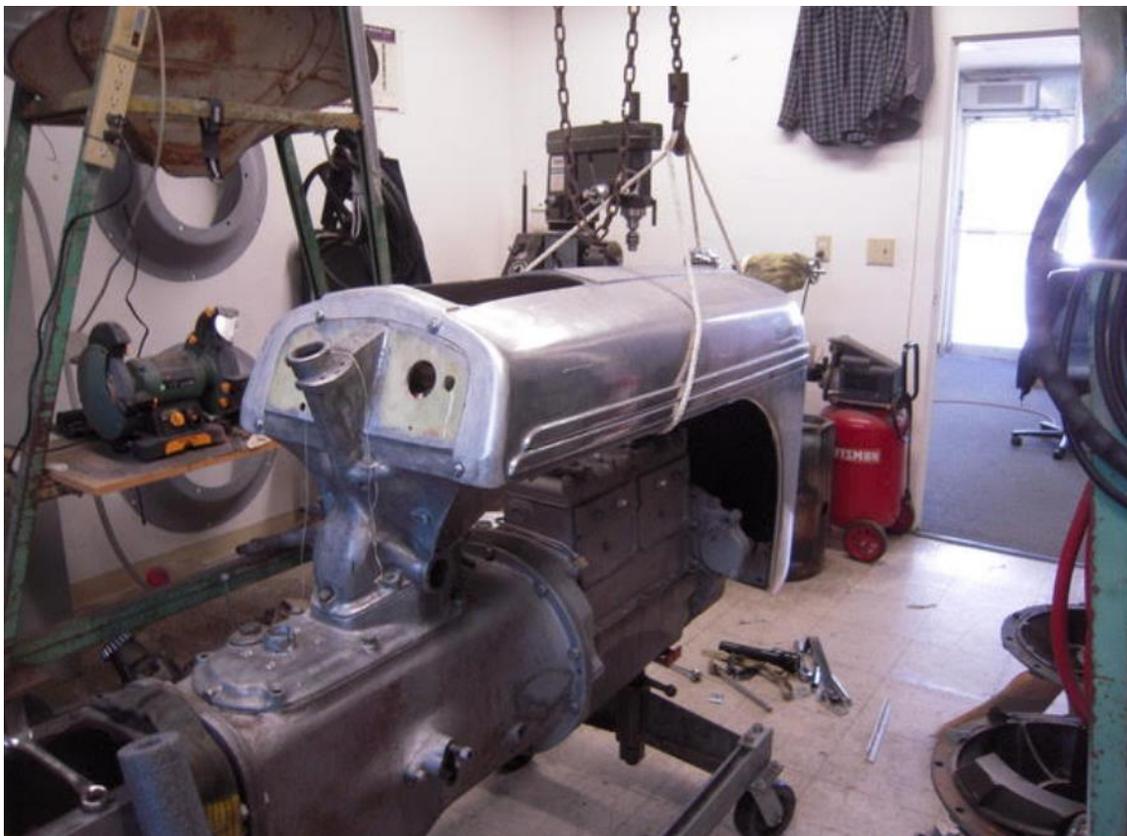
First fitting after grinding and sanding the welds, everything lined up pretty well, and the attachment tabs on the dog legs ended up where they should although some material needs to be added for the lower attachment hole to be drilled properly. The upper hole works fine.

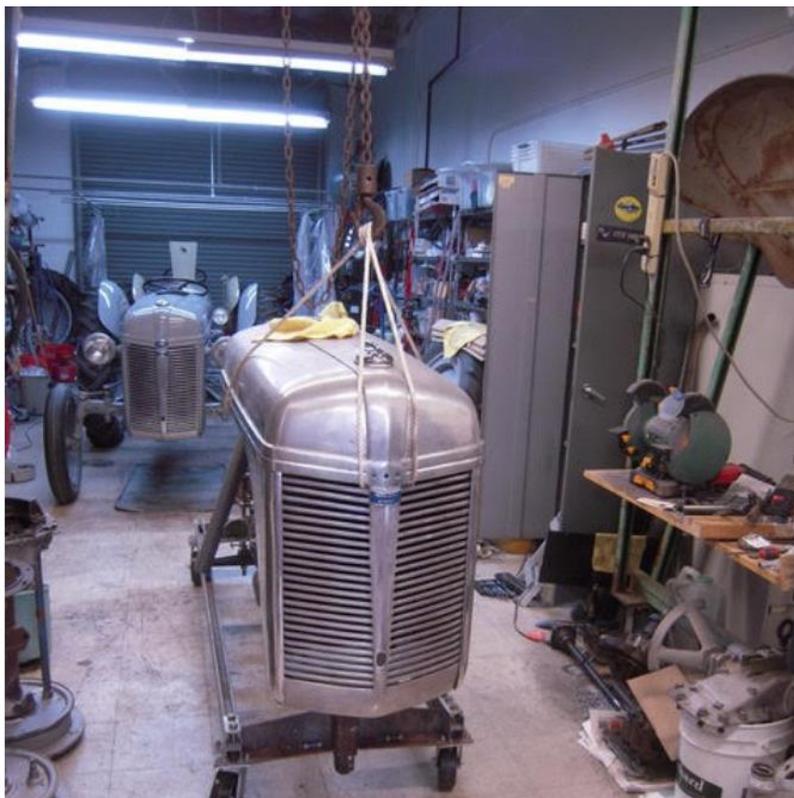
A view from the right rear side.

The radiator is fitted to ensure the cap centers and is reasonably spaced above the hood.

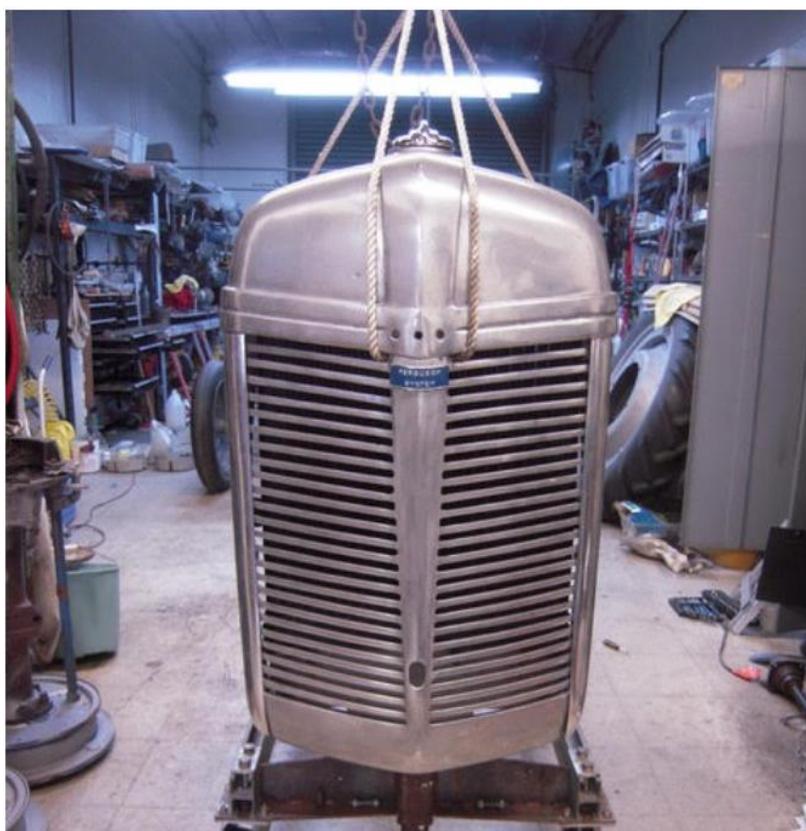
I wanted to get all this work done before splitting the tractor to do the required mechanical work. Having it on the dolly with the axle out allows an easier job of fitting it all together.
